Sediment Monitored Natural Restoration Initial Case Studies

**RTDF
Sediment
Remediation
Action Team**

Clay Patmont

March 11, 2002

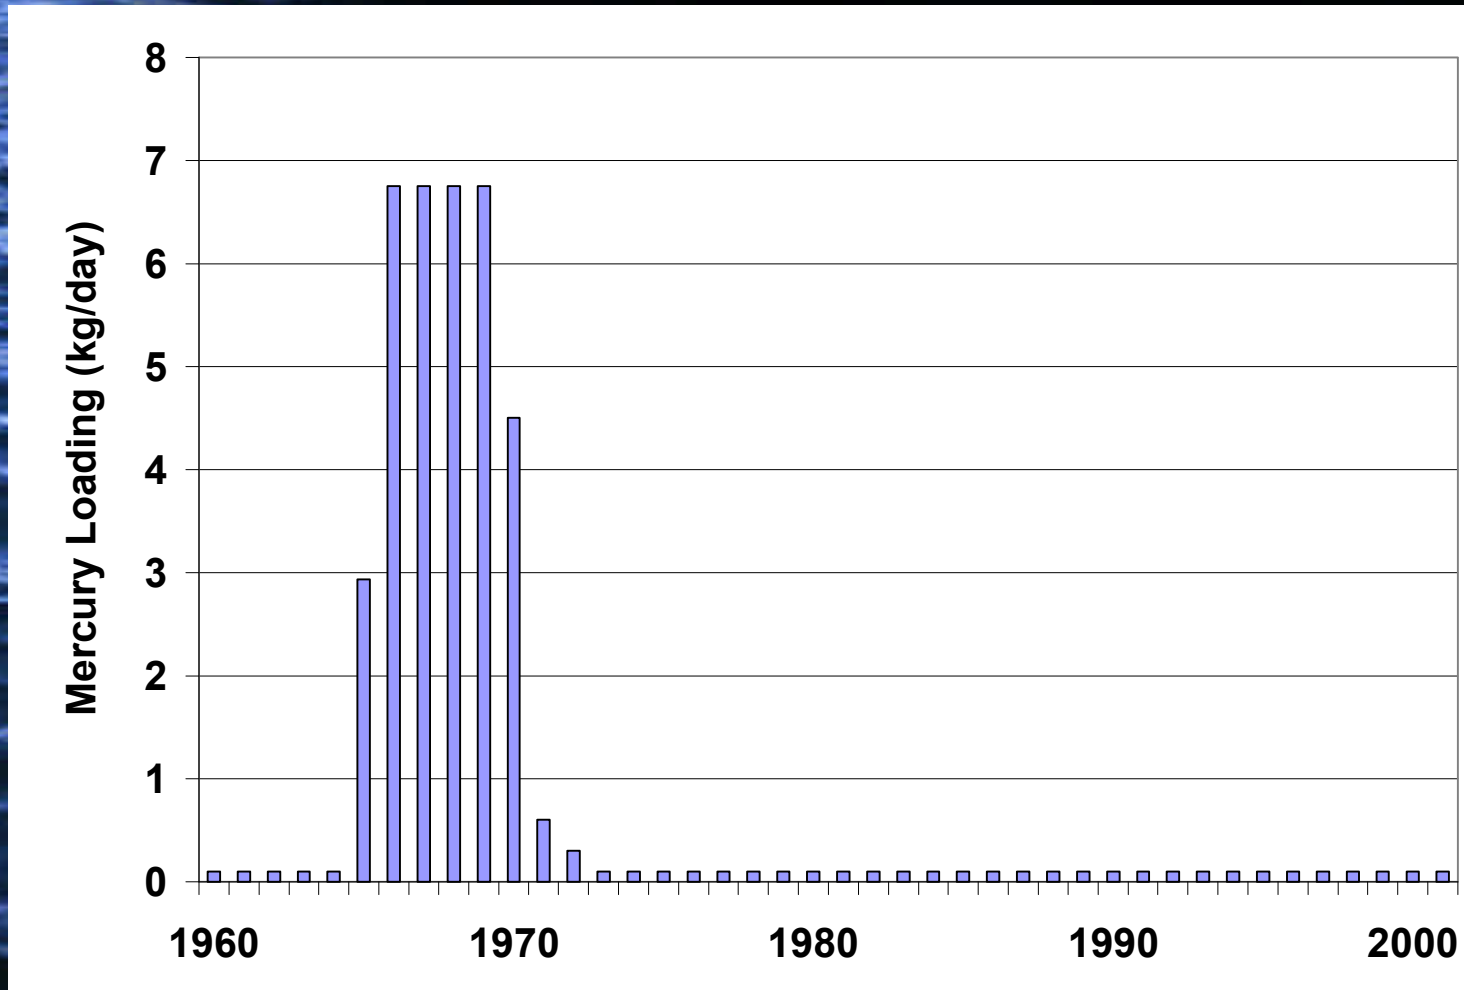
Mercury Release and Source Control: Bellingham Bay

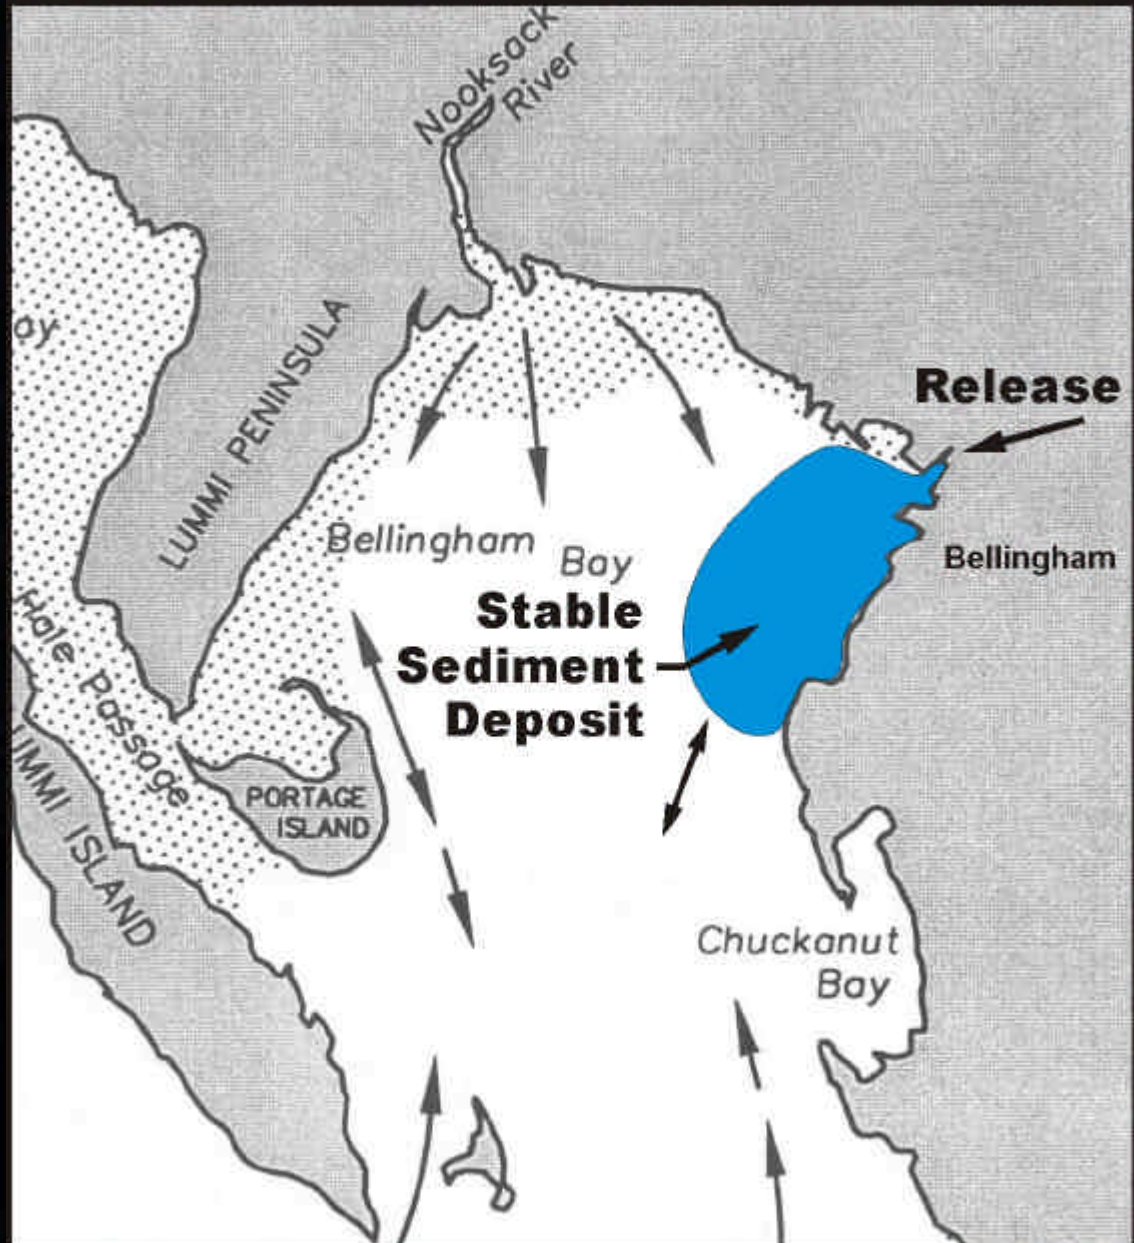
Sediment Deposition and Stability:

Bellingham Bay

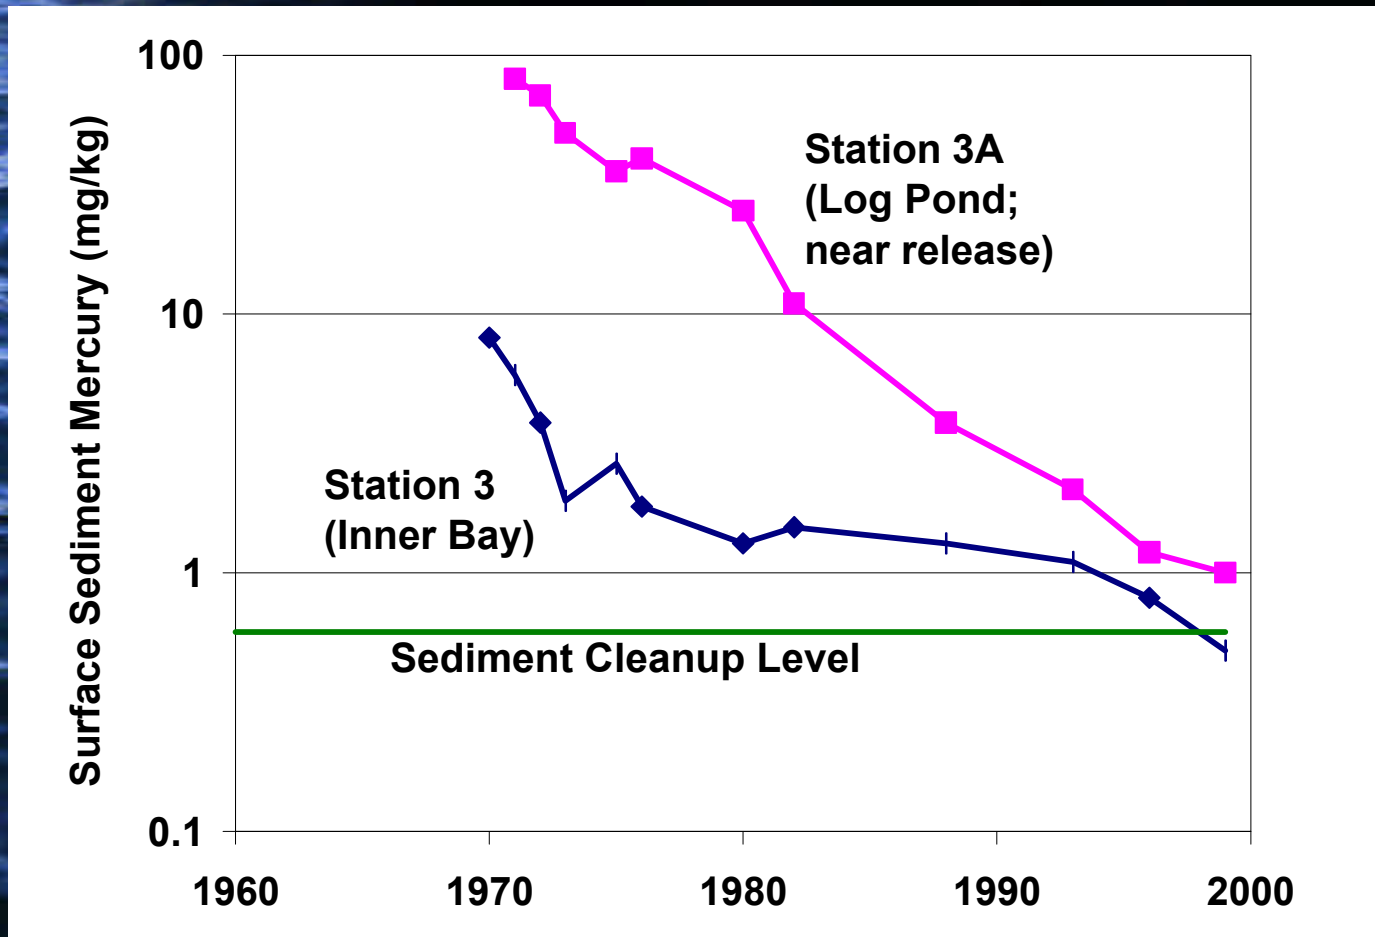
Decline in Surface Sediment Mercury Following Source Control: Bellingham Bay

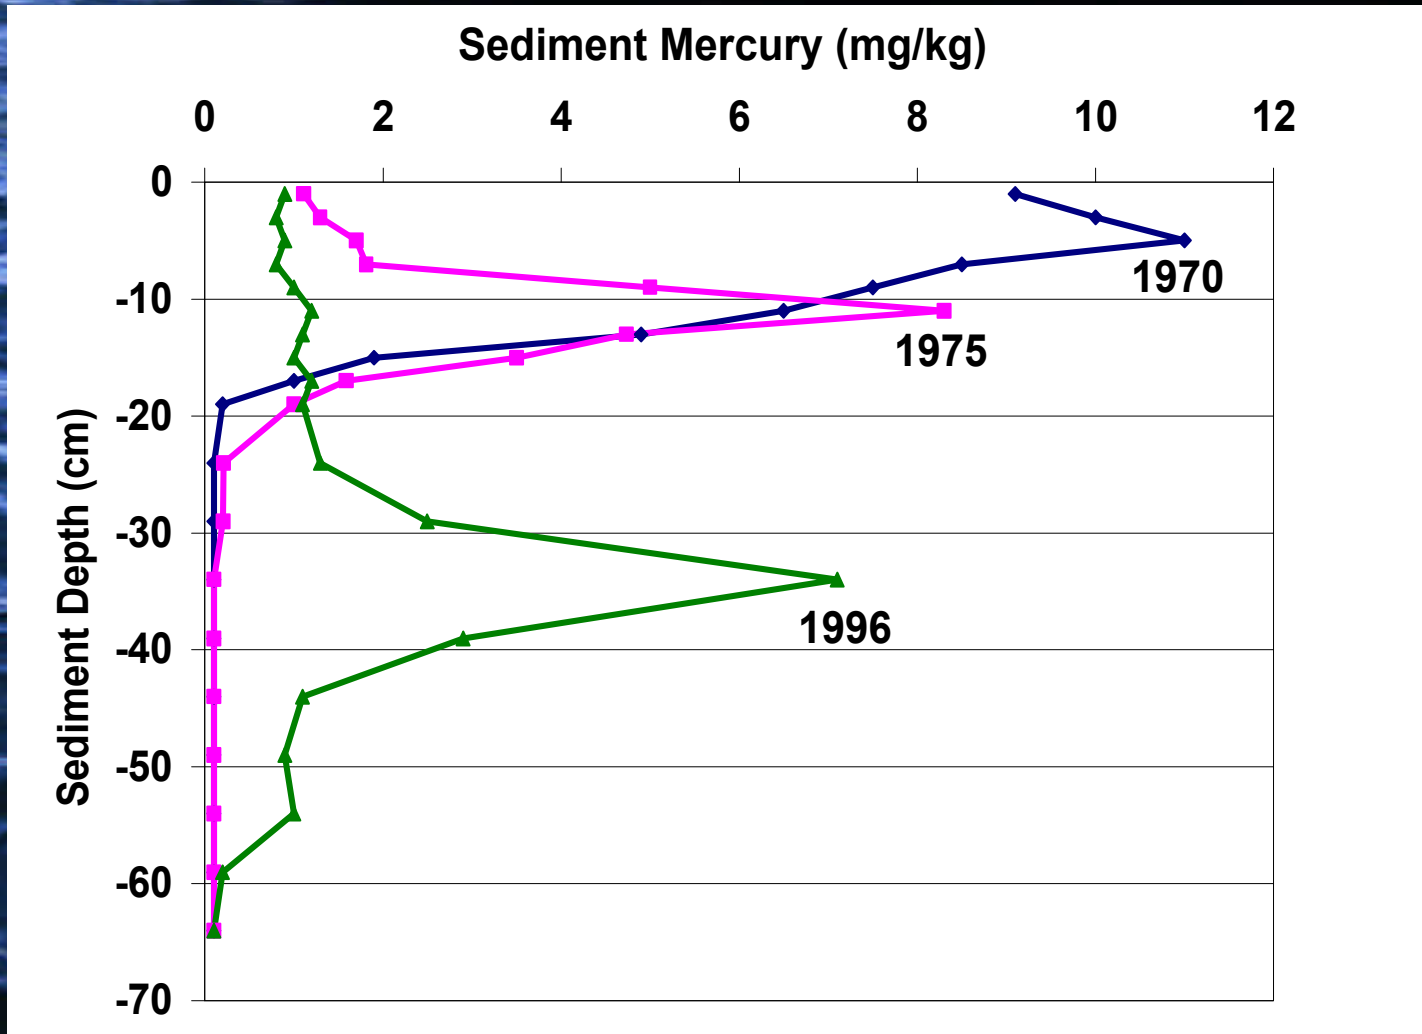
Temporal Change in Core Profiles: Inner Bellingham Bay Station 3

- Initial Model Development in 1980
 - Radioisotope Dating
- Model Refinements in 1989 and 1996
 - Sediment Traps; Resuspension Rates
- Several Models Used
 - Officer and Lynch; WASP
- Model Validation
 - Predicted Changes in Core Profiles

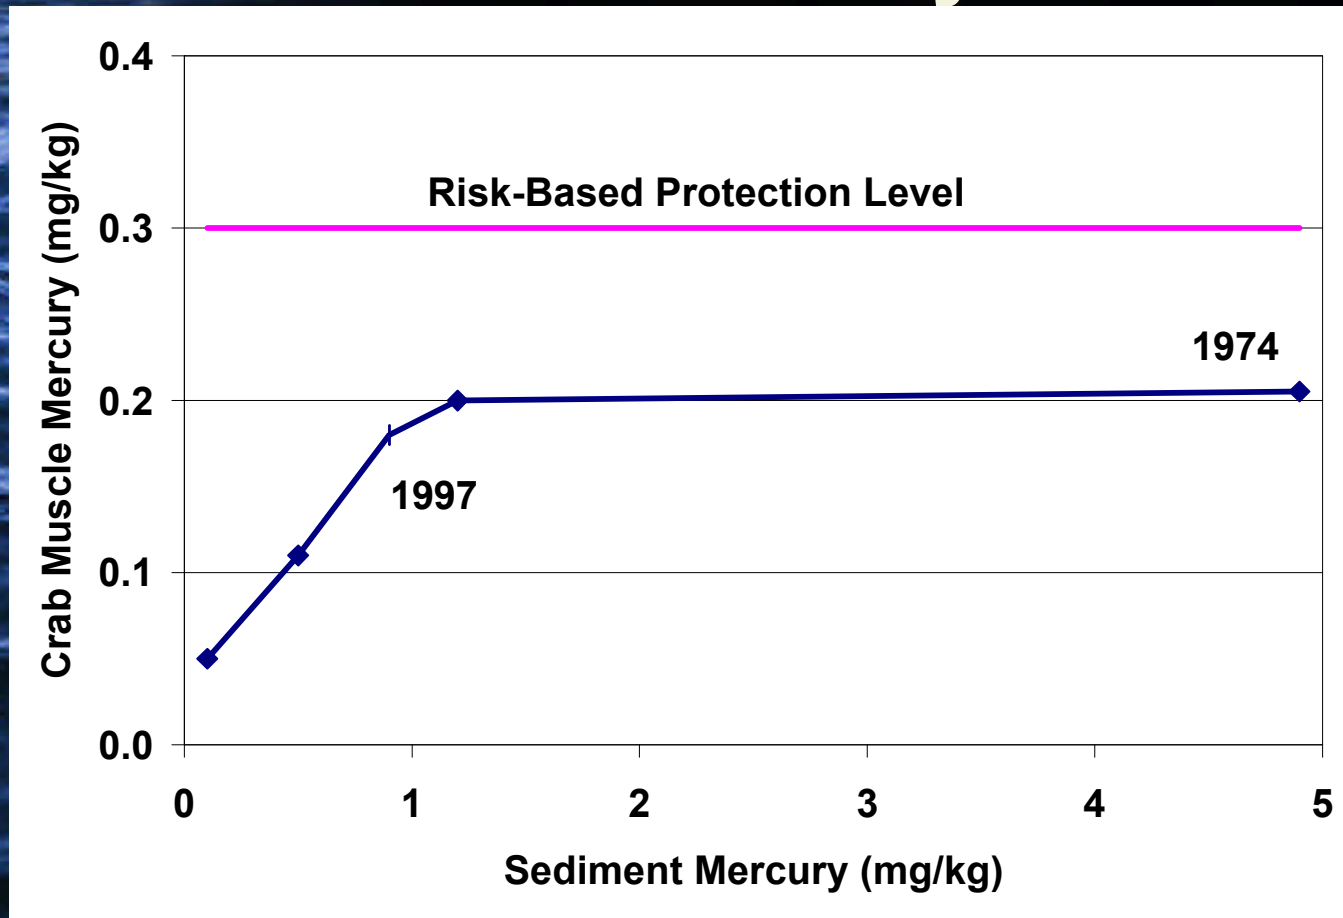
Biological Endpoint Recovery: Reduction in Bellingham Bay Crab Tissue Mercury Levels

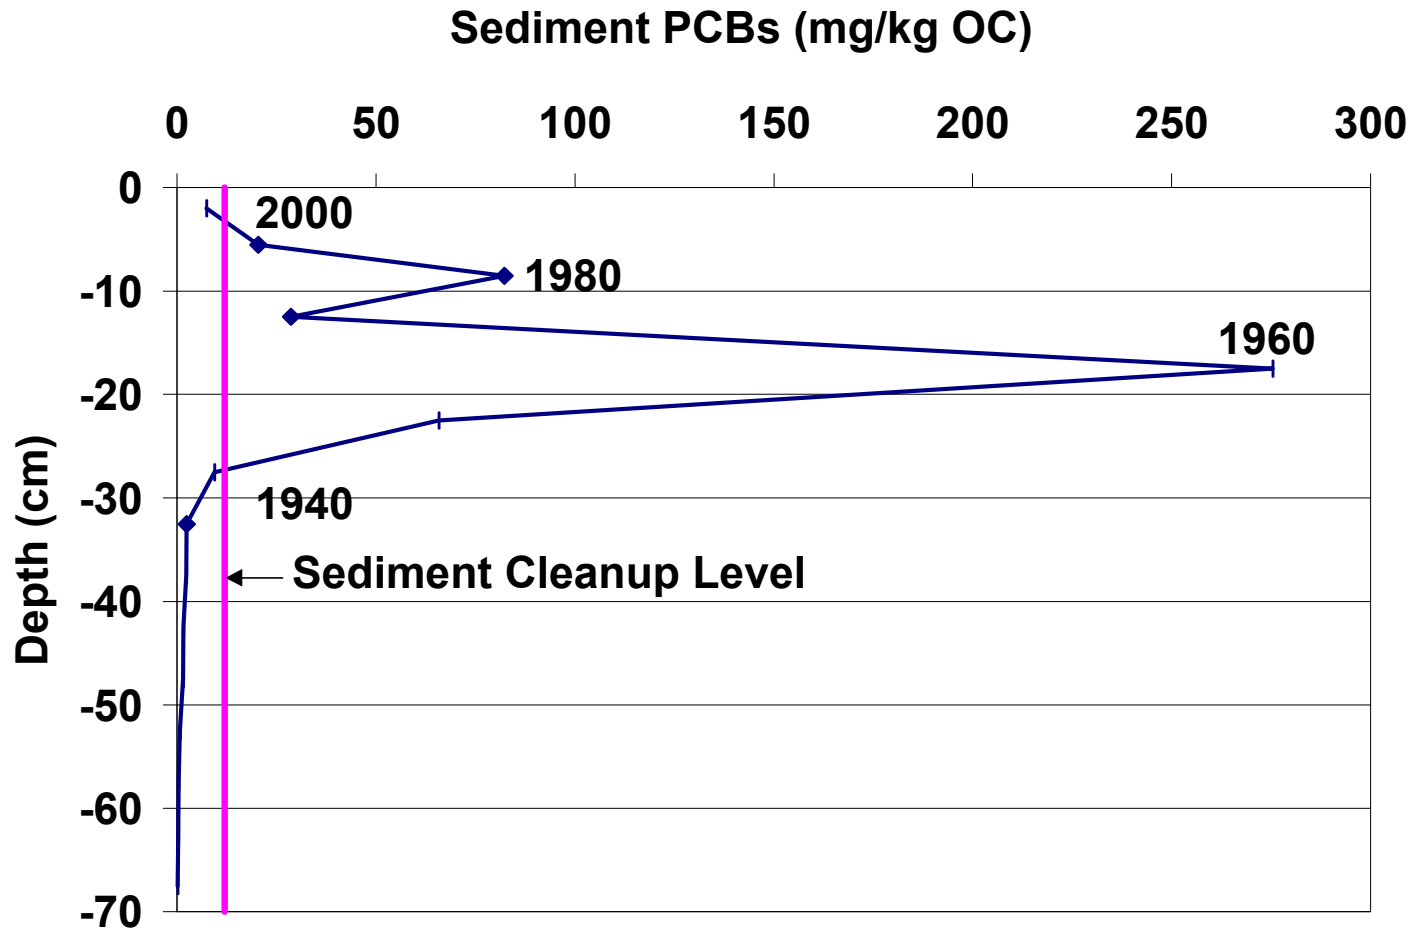
PCB Core Profile: Spokane River Stable Deposit

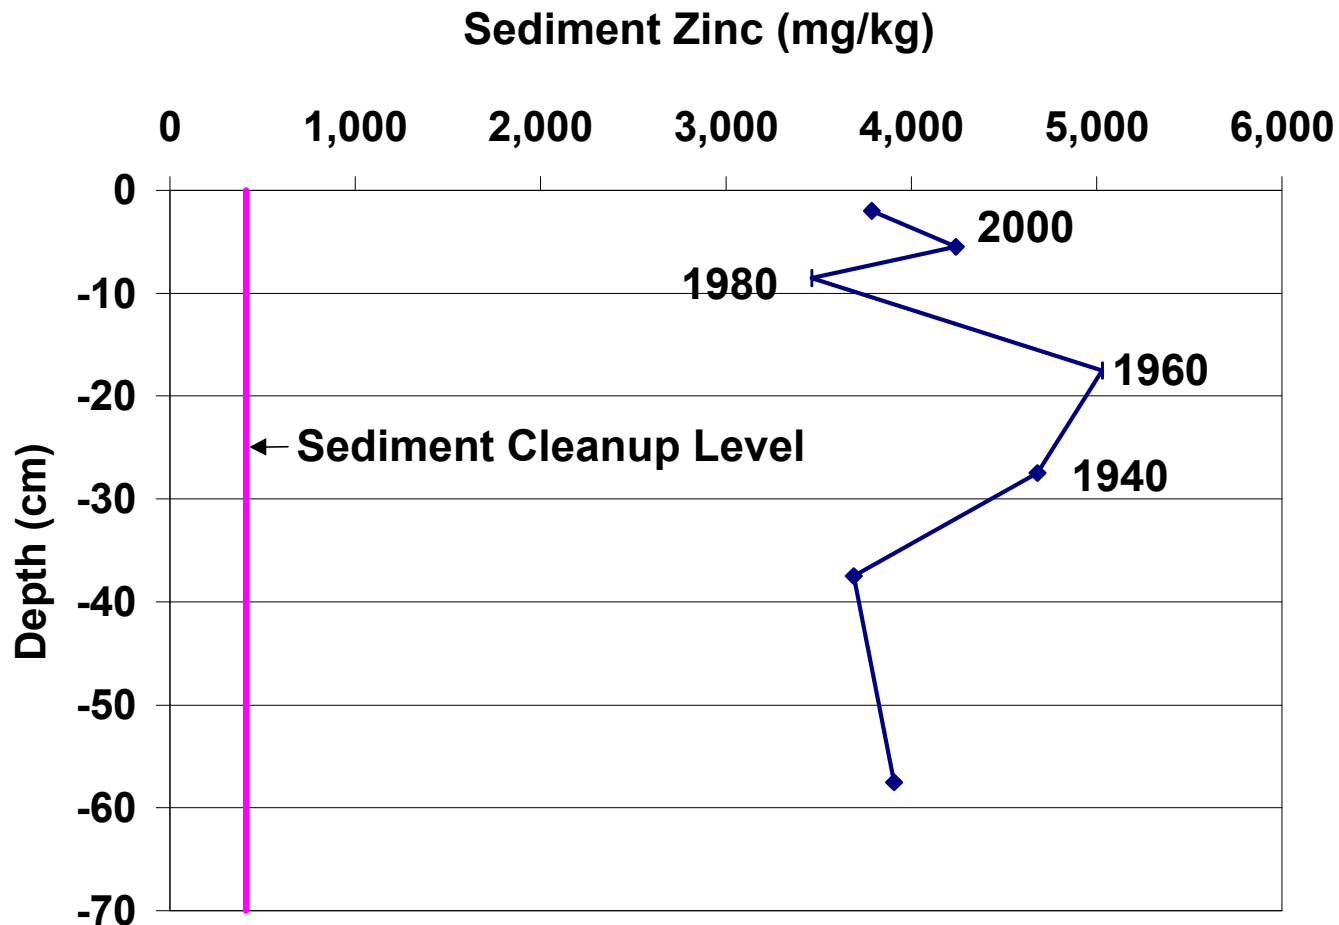
Zinc Core Profile: Spokane River Stable Deposit

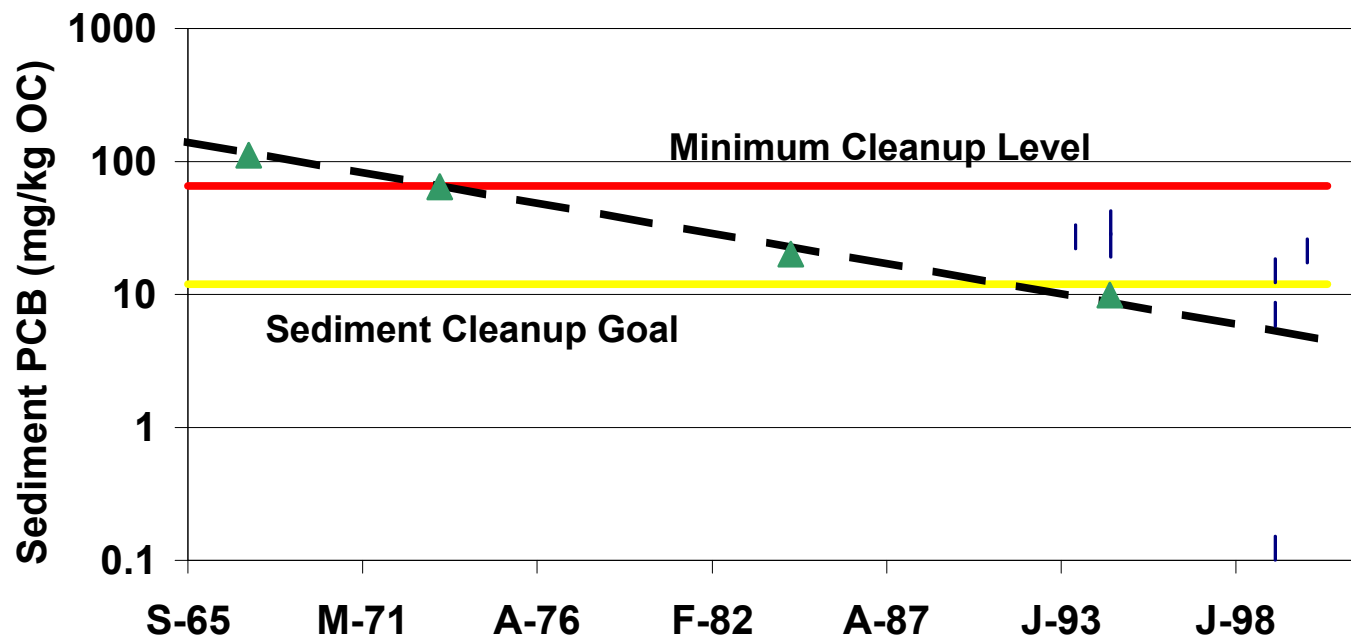
Decline in Surface Sediment PCB Levels Following Source Control: Spokane River

- PCB Releases:
 - Sources Not Well Documented Before 1990
 - Restricted Use After 1972
 - Source Control Complete by 1993
- Metals Releases:
 - Initial Control Efforts Began in 1977
 - Significant Ongoing Mine Tailings Release

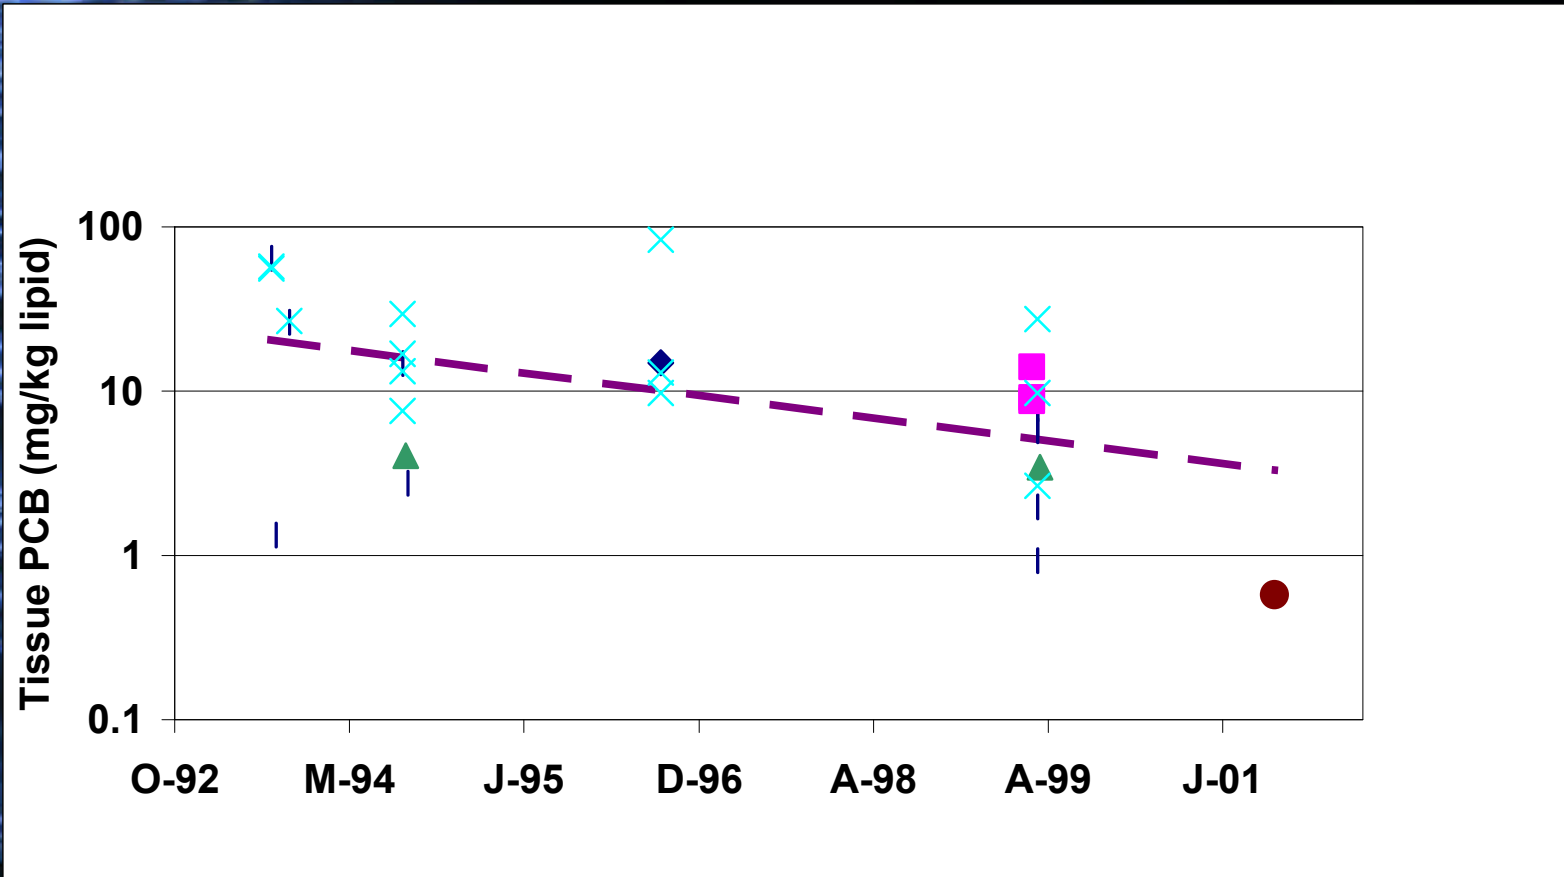
Decline in Fish Tissue PCB Levels Following Source Control: Spokane River

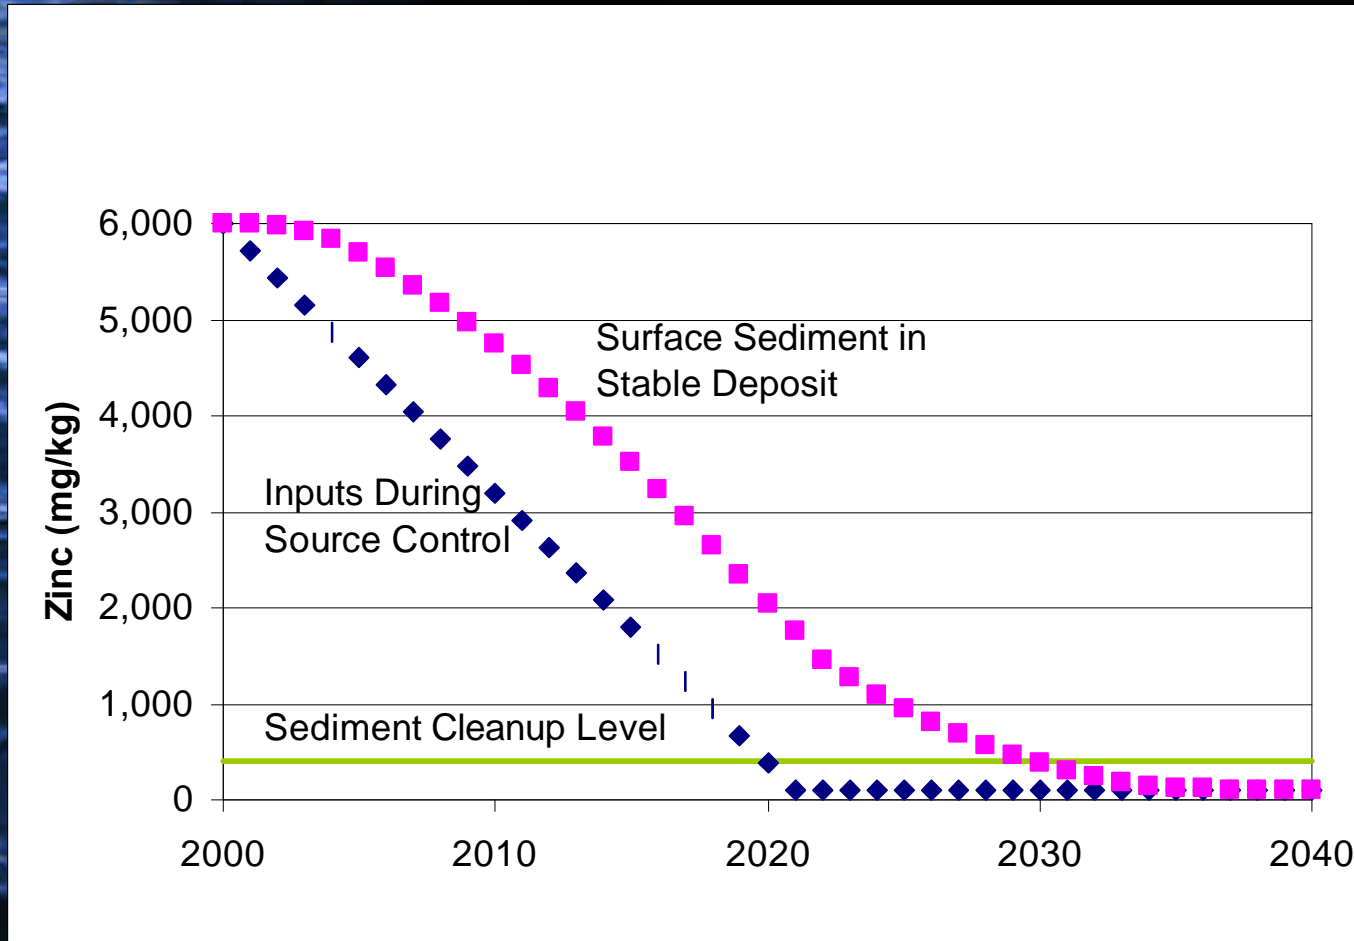
Predicted Recovery of Zinc Following Future Source Controls: Spokane River

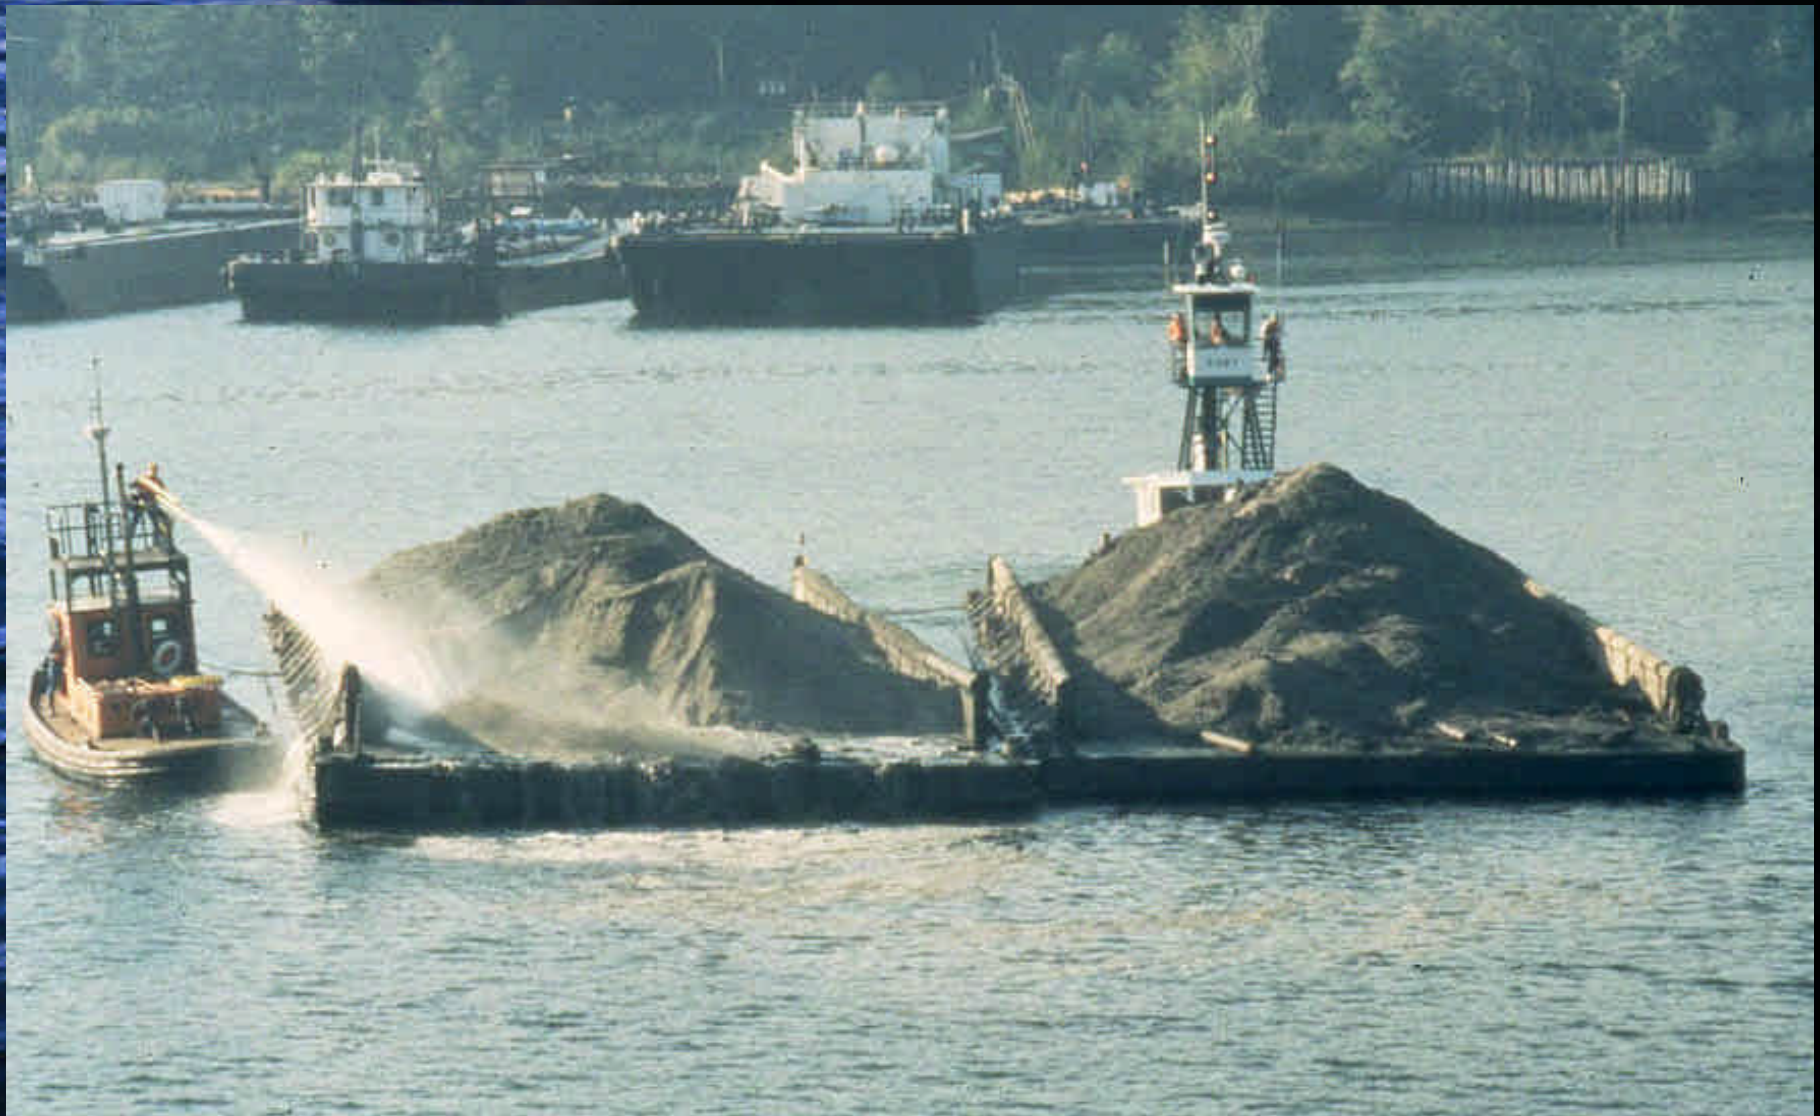
Barge Wash-Off Cap Placement - 1994 & 2001

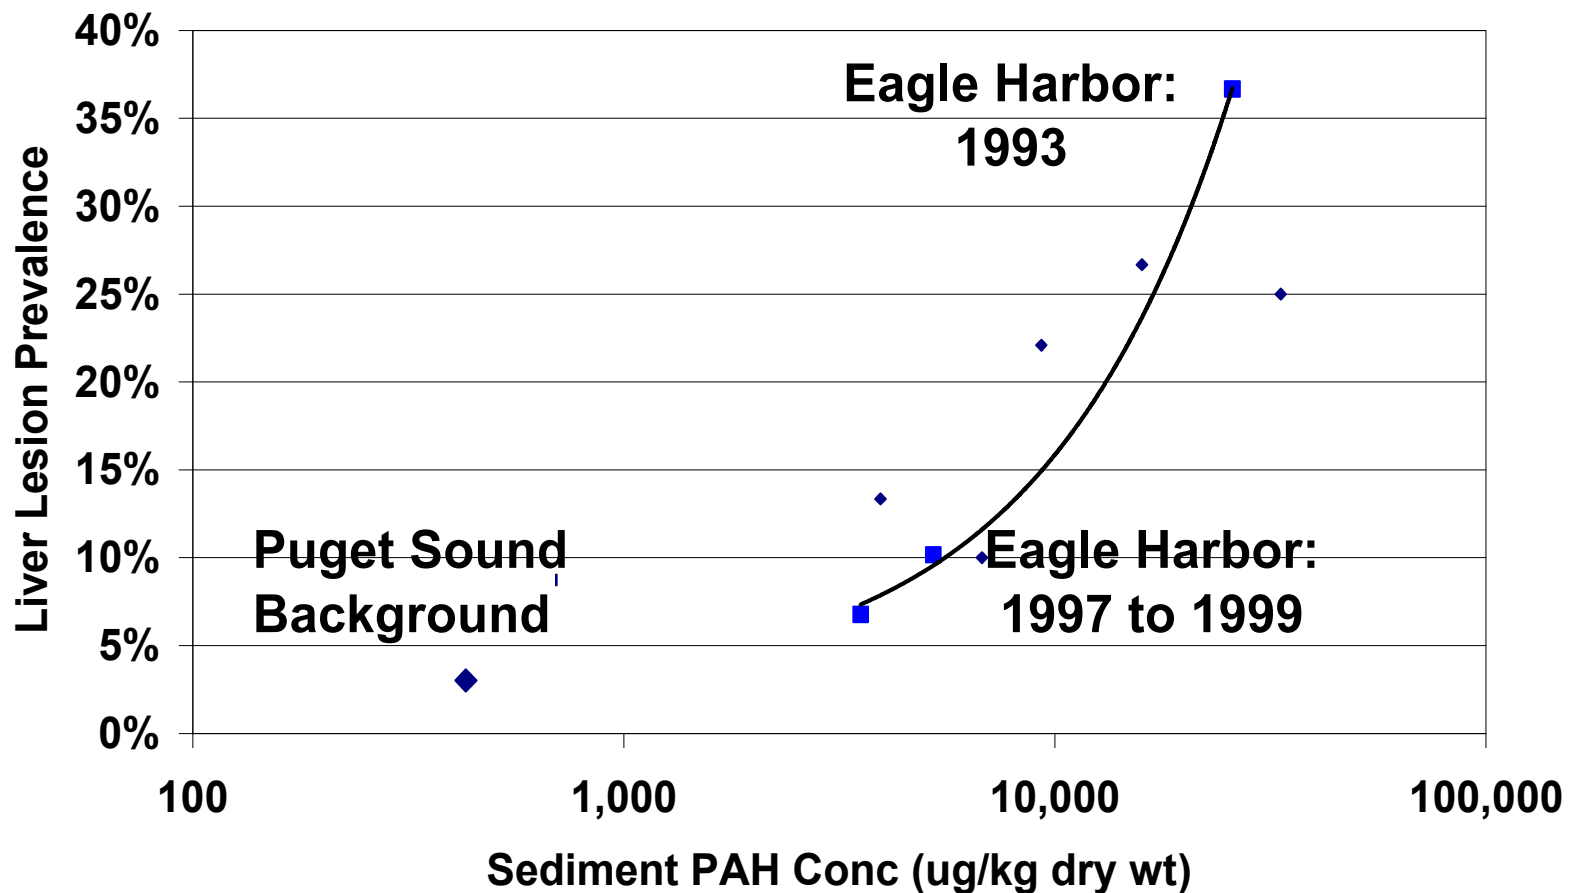
Biological Endpoint Recovery: Fish Histopathology
