Site Work & Installation

Install Reactor

**PRBs in the UK:
New Agency Guidance
Old Friends &
New Sequential Reactors**

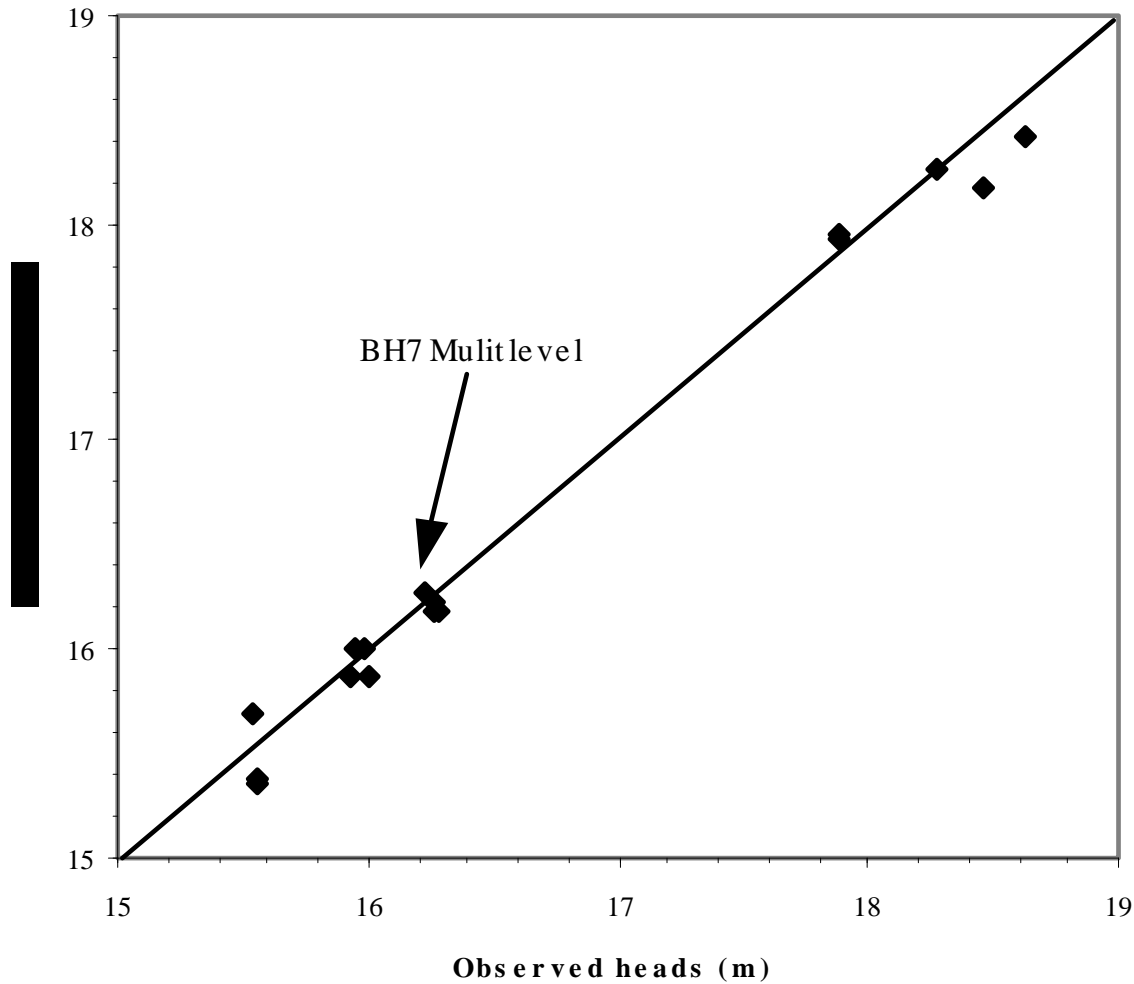
Drawdown of BH7 During Dewatering

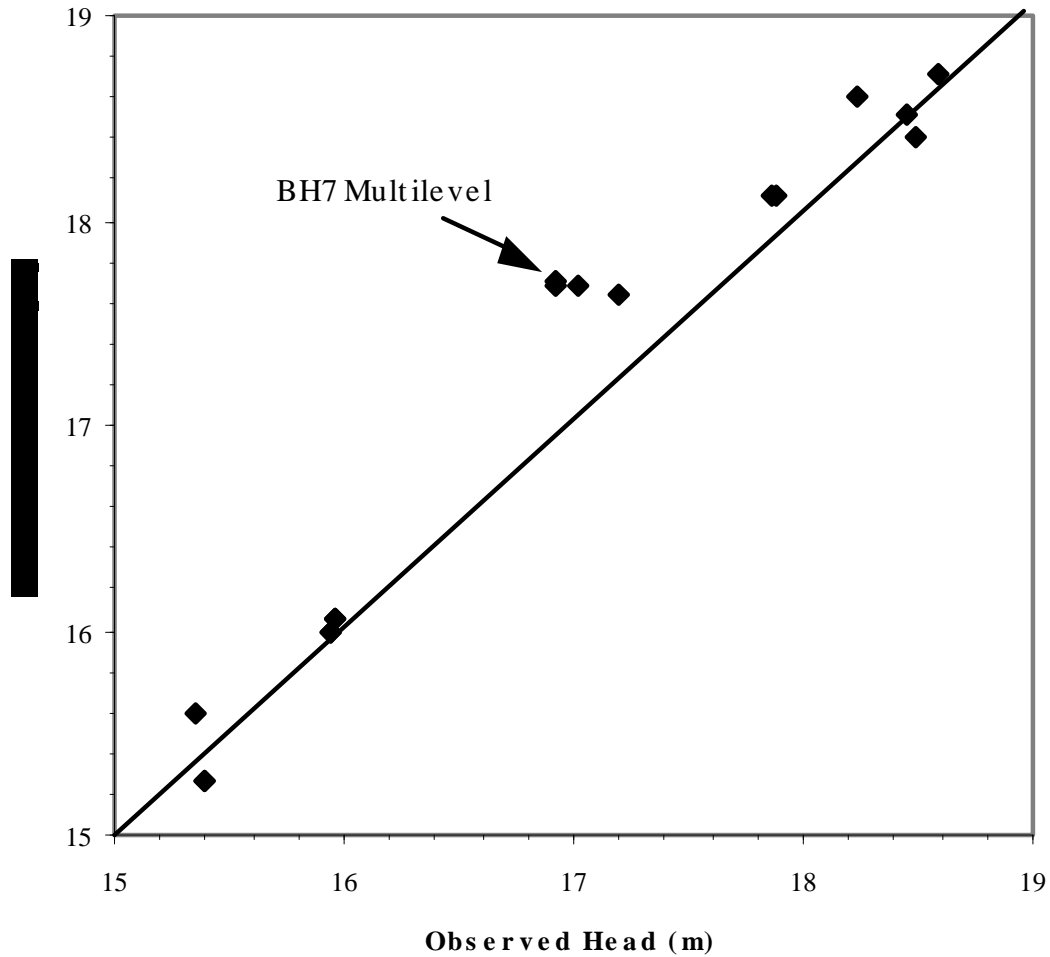
Fit of
Observed
and
Modelled
Water Table
at Site

Impervious
Slurry Wall
 $K=10^{-11}$

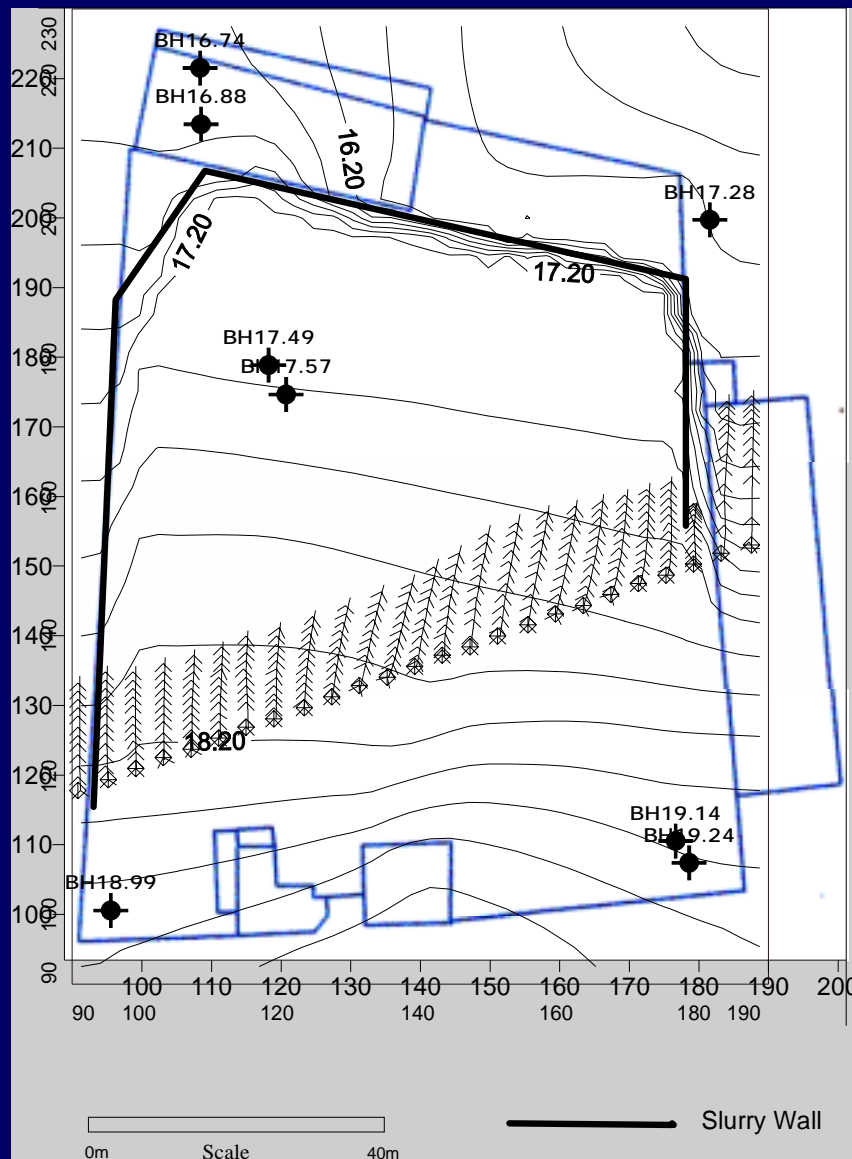
‘Z’ Leakage to
underlying glacial
till deposits

$$K_z = 10^{-9}$$

Water Table and
Flow Lines

'Leaky' Glacial Till

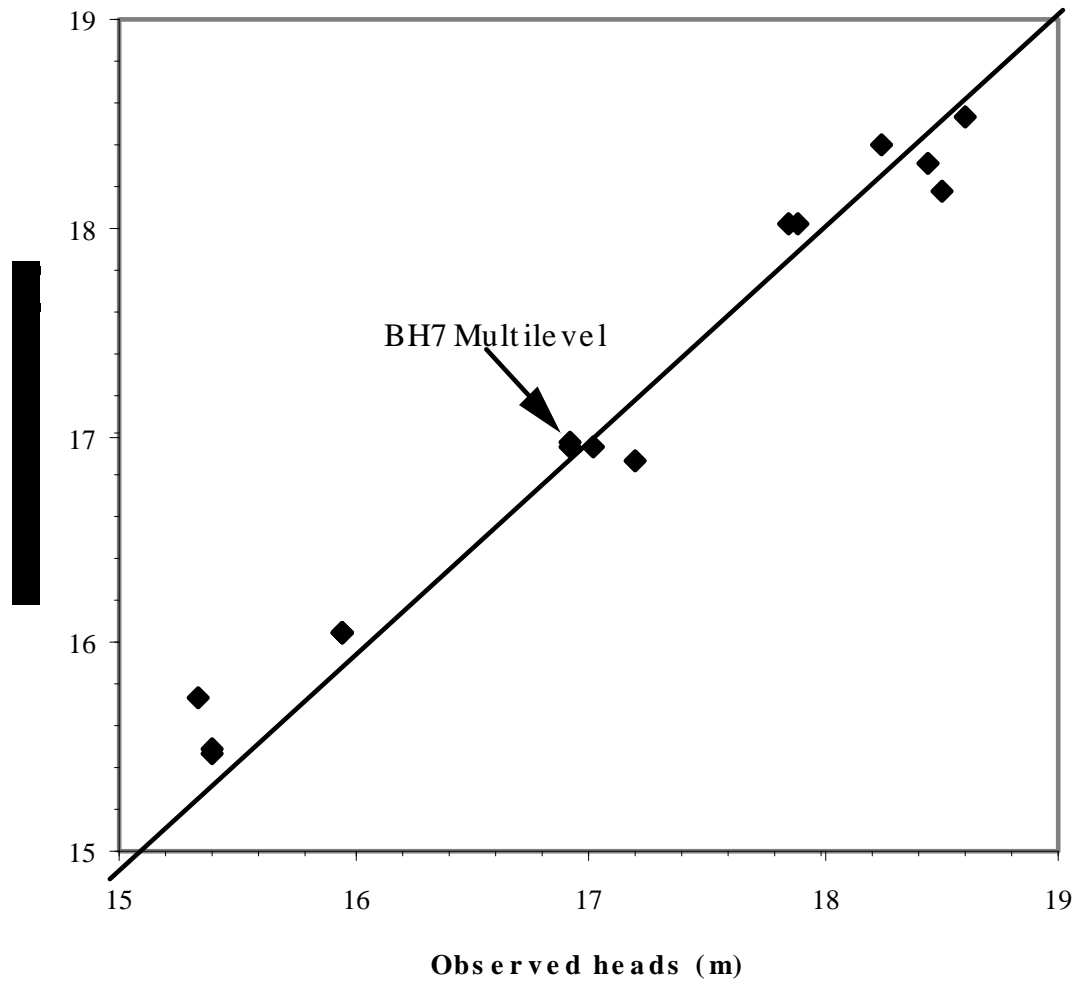
Fit of
Observed
and
Modelled
Water Table
at Site

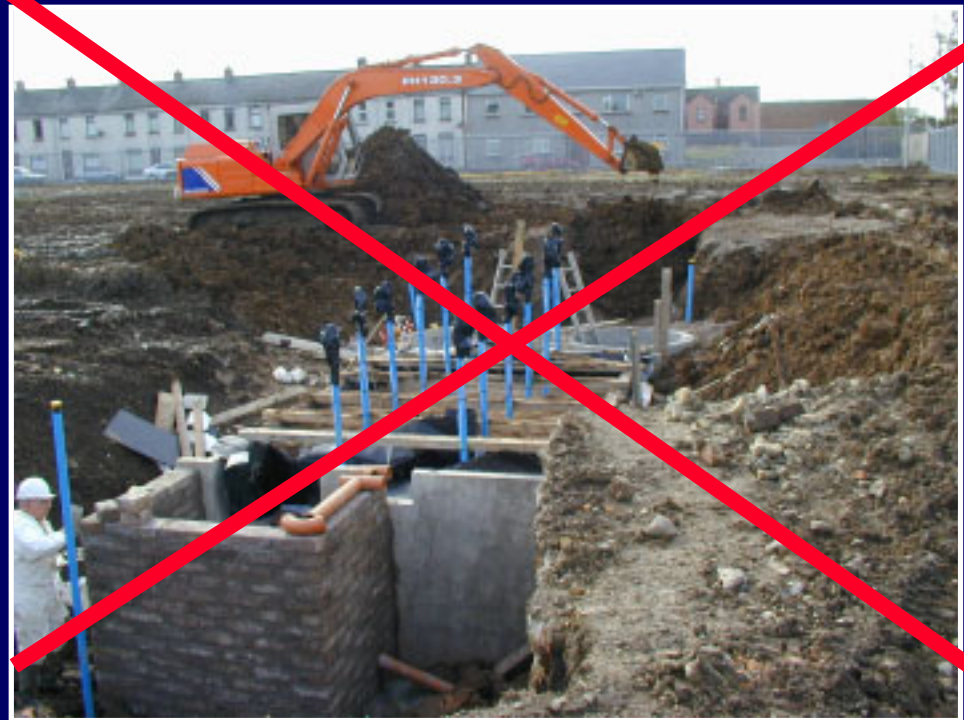
Bob's team took it apart Oct 2002 – Why and lessons:

- ✓ Collect microbiological samples
- ✓ LDPE Liner ripped during heavy rain event
- ✓ 'Cheap construction' allowed by-pass flow (honourable idea but not sustainable)
- ✓ How easy is it to clean one of these out? (Pick Your Weather!!!)
- ✓ Try new hydraulic design internally for controlled flow

✓ We are changing box
as Flood ruined the structure
(1 monthly average rainfall in
1.5 hours saw all streets and
site completely flooded!)

New Box will be shuttered

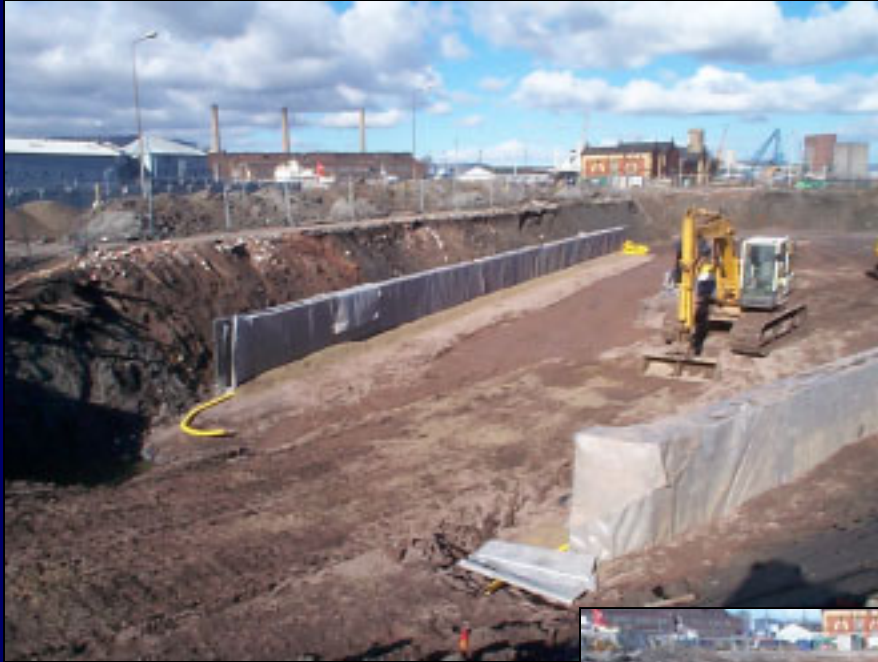
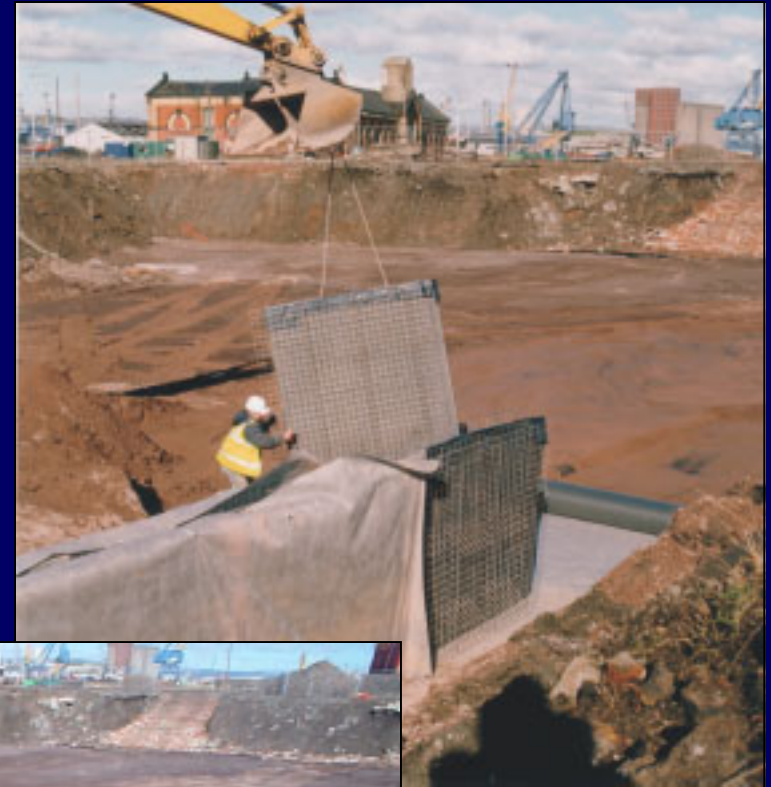
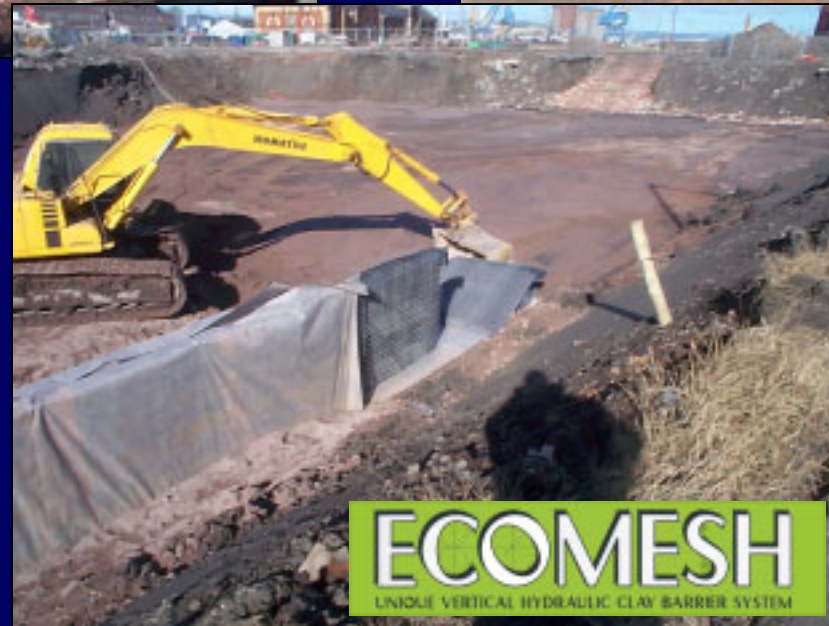
Treatment Cell at
QUB Science Park

Treatment of TPH
Source via in-situ
bioremediation over
next 10 years

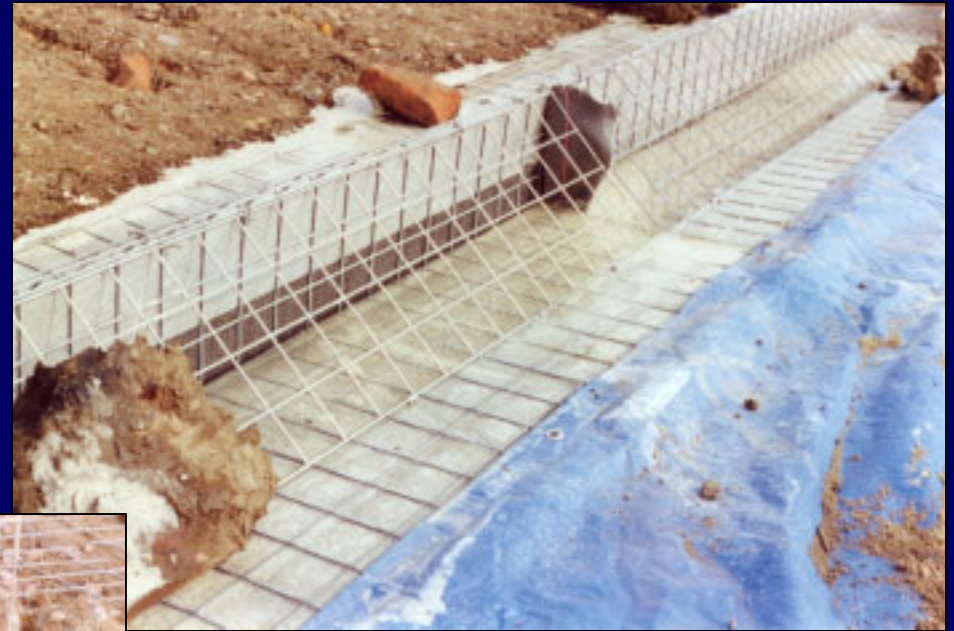
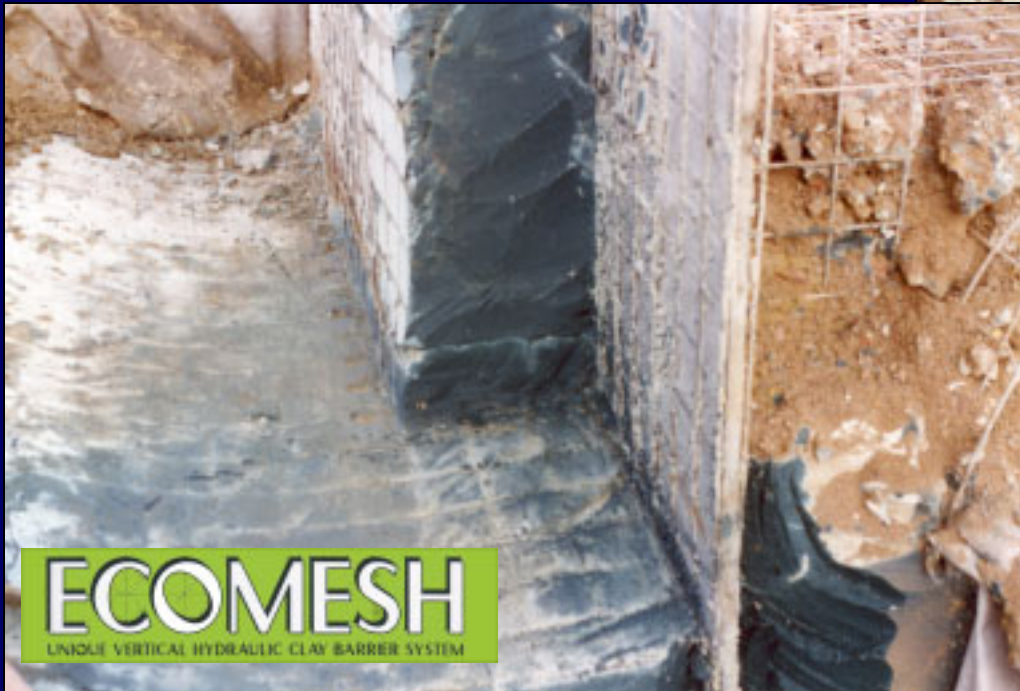
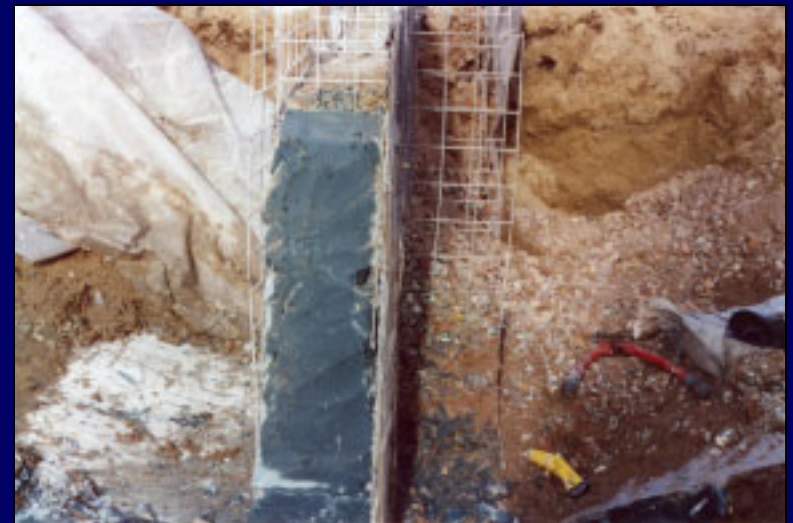
ECOMESH
UNIQUE VERTICAL HYDRAULIC CLAY BARRIER SYSTEM

Design of geotechnical systems to protect funnel and simplify the use of trench-and-gate PRB Installations

EcoMESH and Keller Ground Engineering (Hayward Baker)
