# Design and Construction of an ET Cover System in the Eastern U.S.

Beth A. Gross, P.E.  
GeoSyntec Consultants  
Austin, Texas

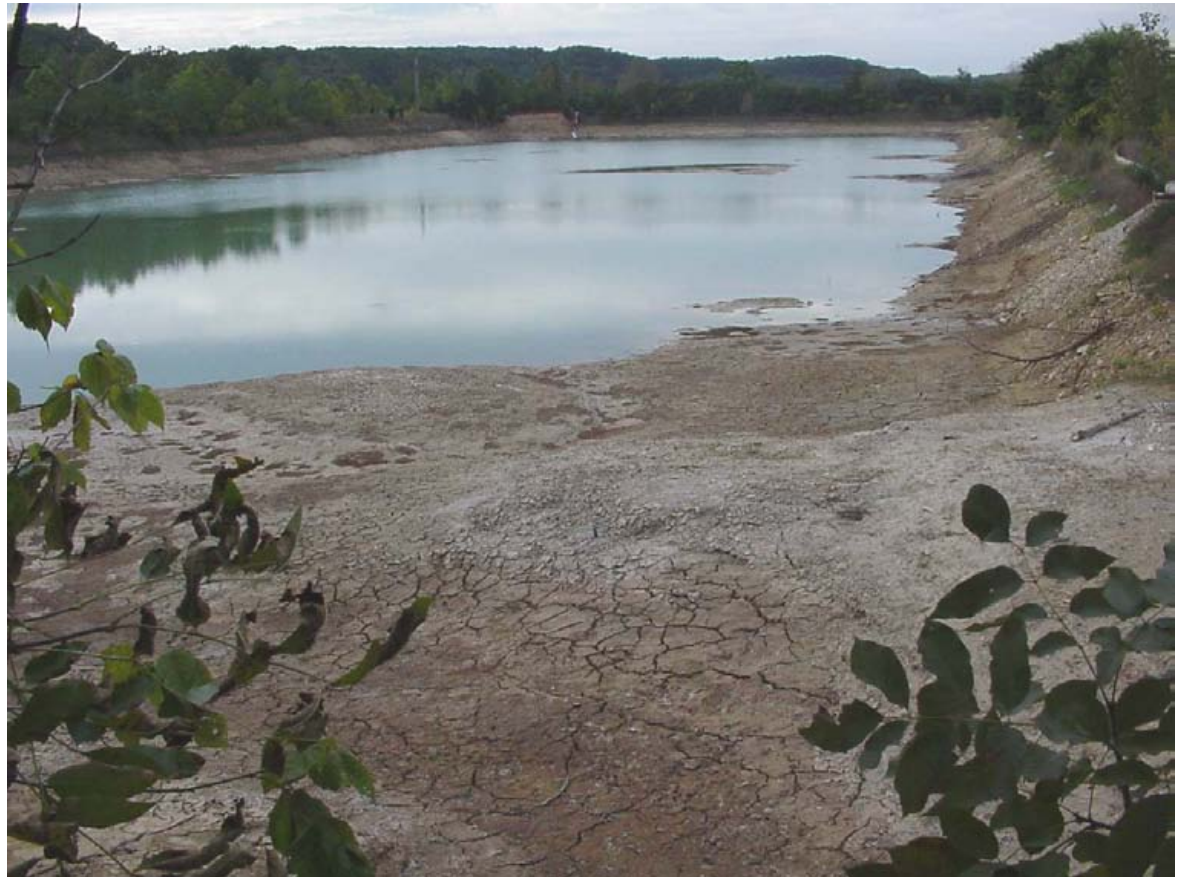
# Design Issues

## Issues

- Grading
- Settlement
- Hydraulic conductivity  
( $\leq 1 \times 10^{-8}$  cm/s)

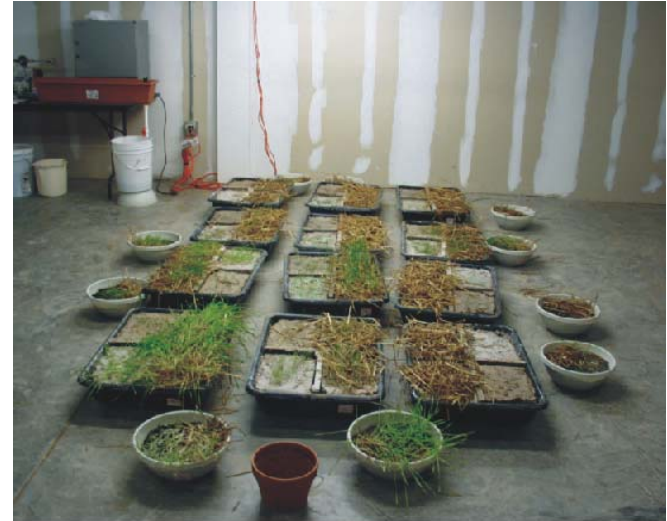
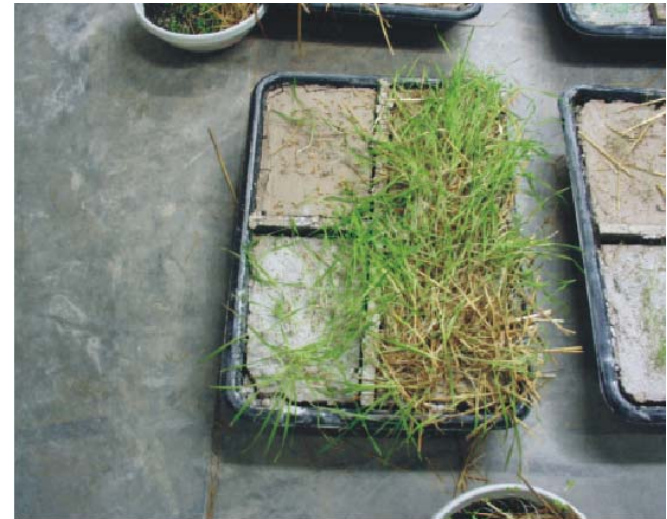
# Plant Testing

Greenhouse and field testing of plants to evaluate:

- Ability to sustain growth in fly ash and sulfate sludge
- Dewatering effects

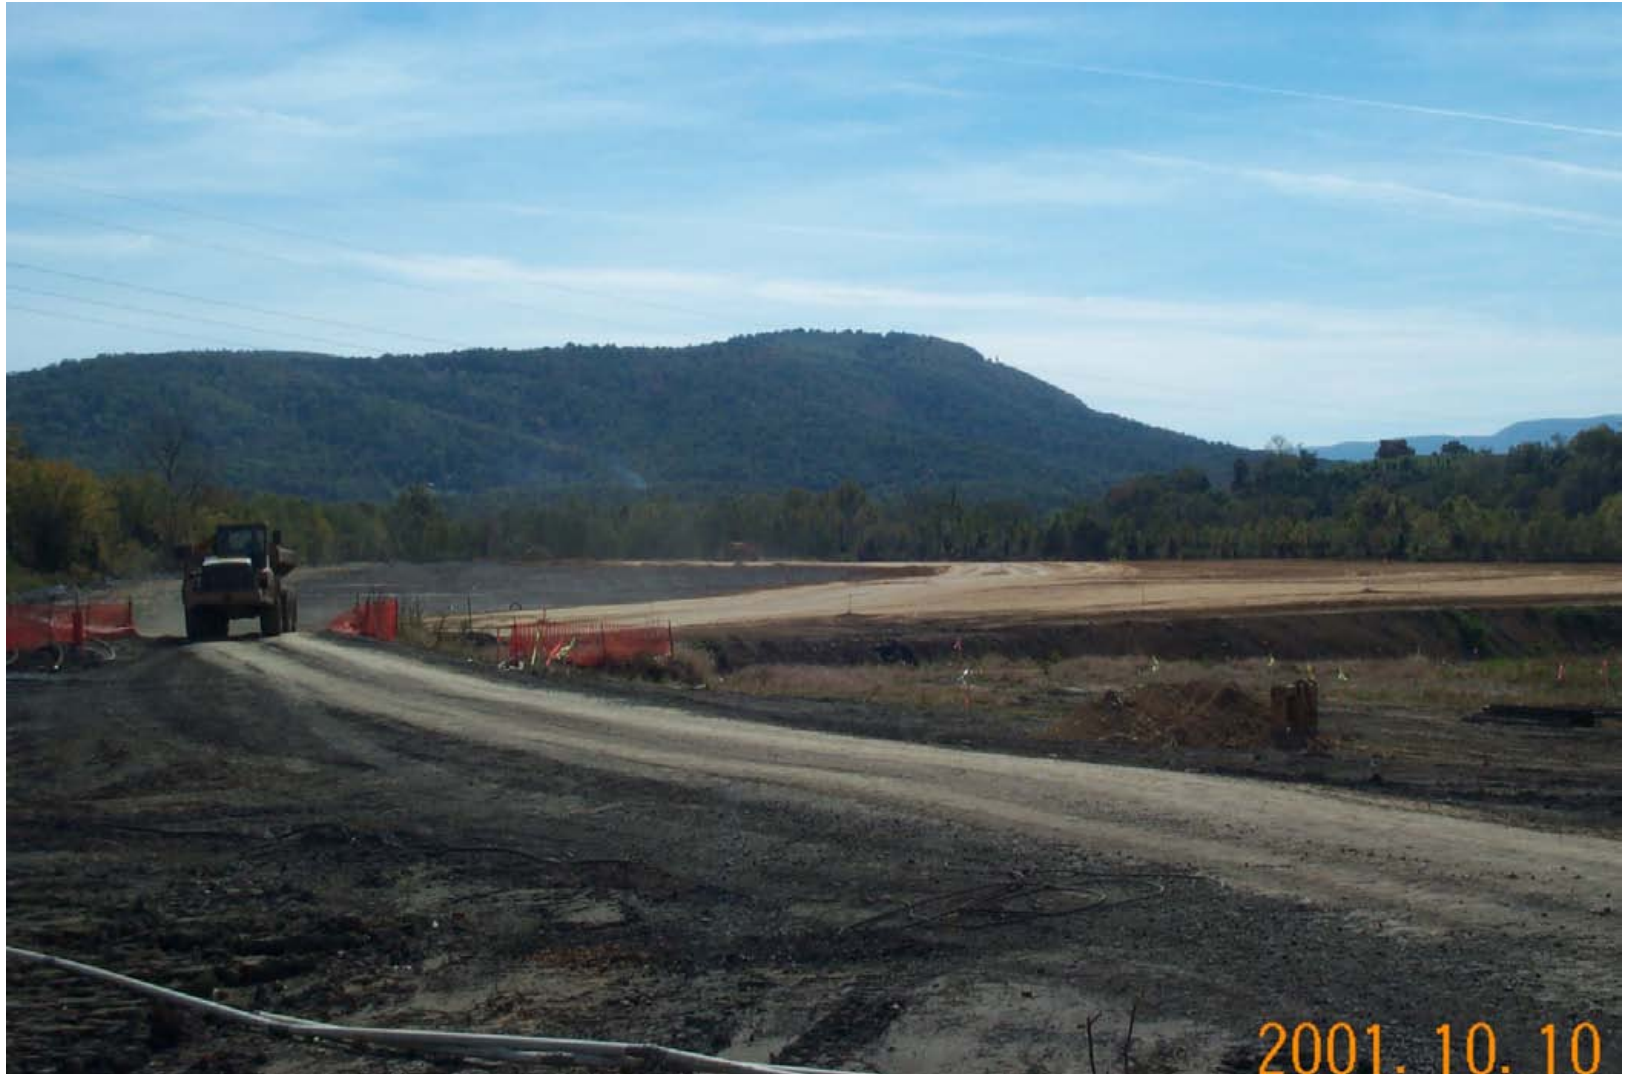
# October 2001

# ET Cover Construction (FAB6)

- Borrow area soil
  - Silty clay, little to some sand and gravel (USCS)
  - Clay loam (USDA)
  - Remolded  $k_{\text{sat}}$
- Placed with dozer
- No compaction criterion
- In-place soil (Shelby tube samples)
  - Dry Density: 1.72-1.75 g/cm<sup>3</sup>
  - $k_{\text{sat}}$ :  $1.1 \times 10^{-6}$  to  $3.0 \times 10^{-6}$  cm/s
- Soil tested to assess need for amendments, and nitrogen has added
