# *The Quest for Consistency among Regulatory, Design, and Post-closure Monitoring Frameworks*

Jorge G. Zornberg, Ph.D., P.E.  
*The University of Texas at Austin*

*Designing, Building, & Regulating  
Evapotranspiration (ET) Landfill Covers*  
March 10, 2004

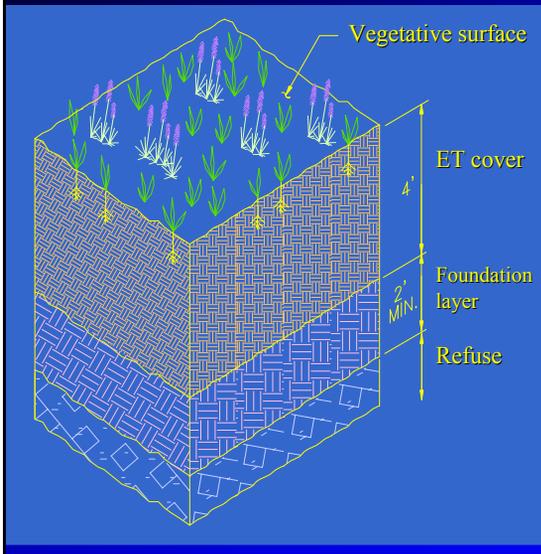
## *What does an ET cover look like?*

### An ET cover:

- Controls percolation
- Is stable under static and seismic conditions
- Controls erosion
- Is aesthetically pleasing
- Is easy to maintain
- Is cost-effective

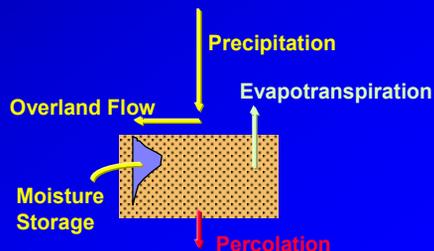
## *Alternative Cover Systems for Arid Climates: Equivalence*

### Prescriptive Cover ("Barrier" System)

### ET cover ("Reservoir" System)

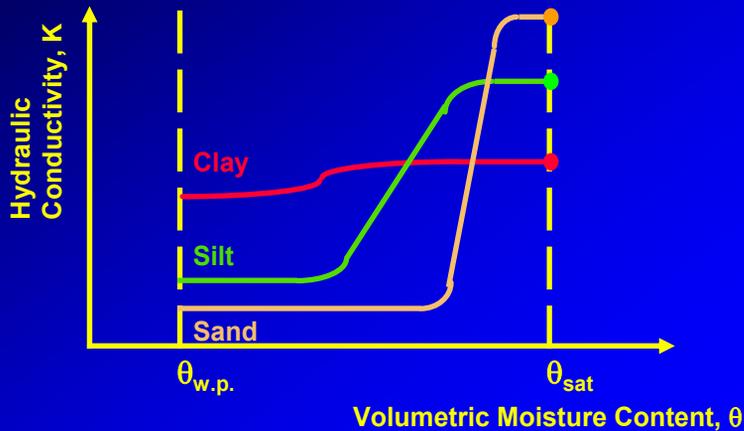
## What are the Hydraulic Properties of the ET cover Material?

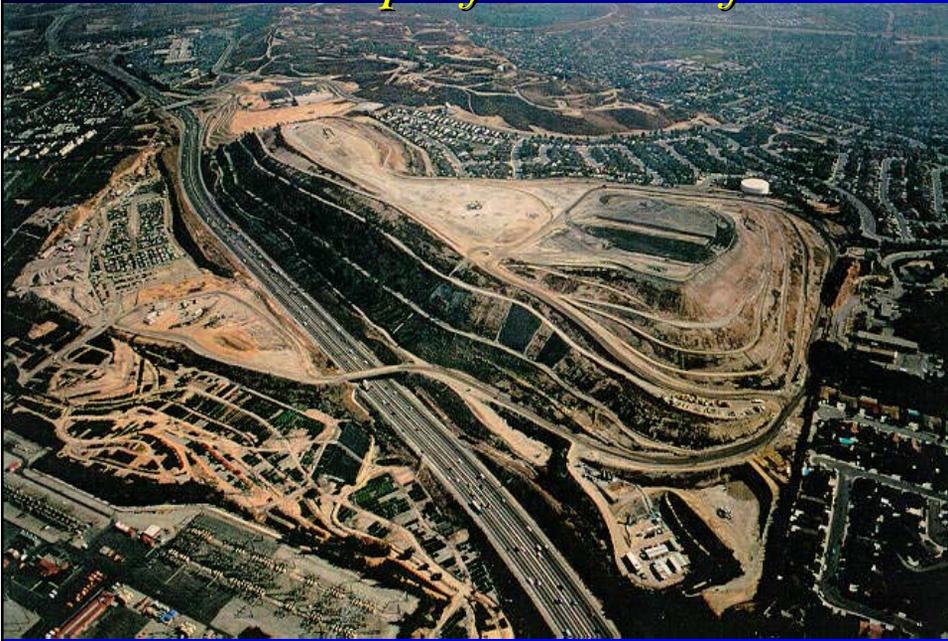
*OII Superfund Landfill*

# OII Superfund Landfill

- Site was originally a sand and gravel quarry
- 1948 Waste disposal initiated
- 1954 Disposal of liquids in native soil
- 1964 California buys 28 acres for Pomona Freeway (170,000 cu yards of waste in ROW)
- 1976 300,000,000 gallons liquid waste permitted
- 1978 Gas control initiated. Daily cover required
- 1983 Liquid disposal ceased
- 1984 Waste disposal ceased
- 1997 Final cover design completed
- 2000 Construction of cover system completed

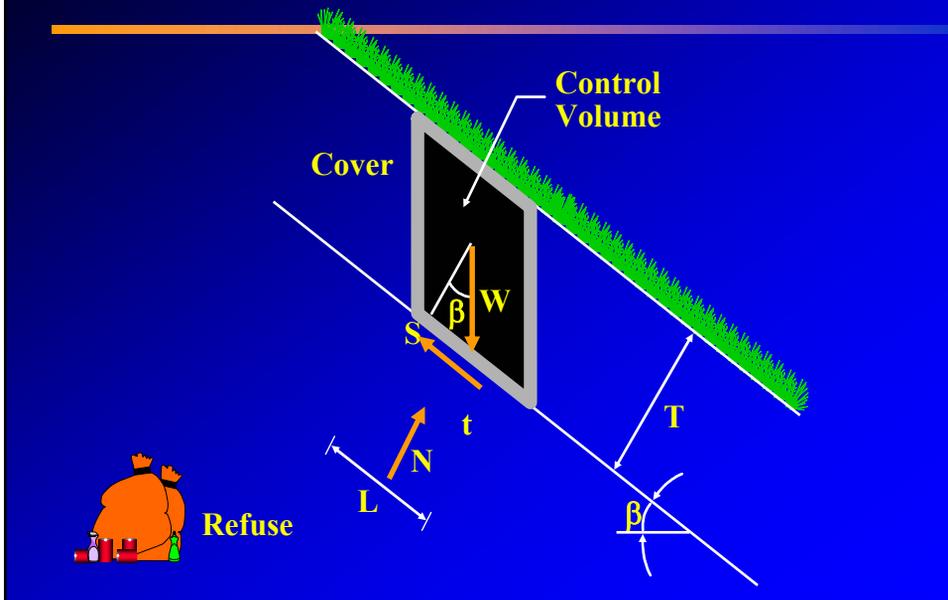
## *Unreinforced Infinite Slope*

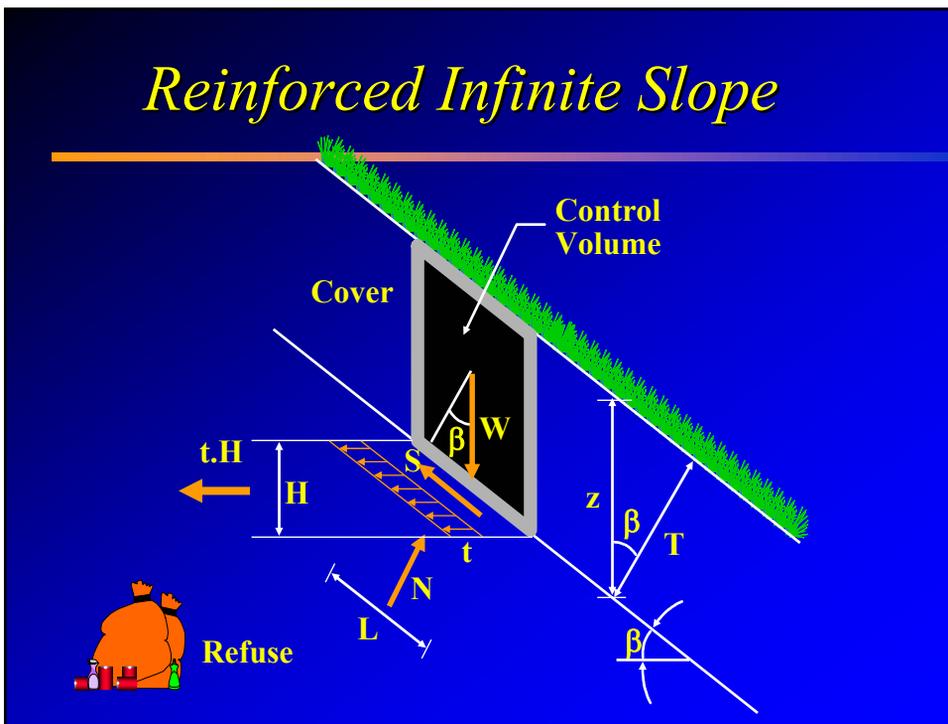
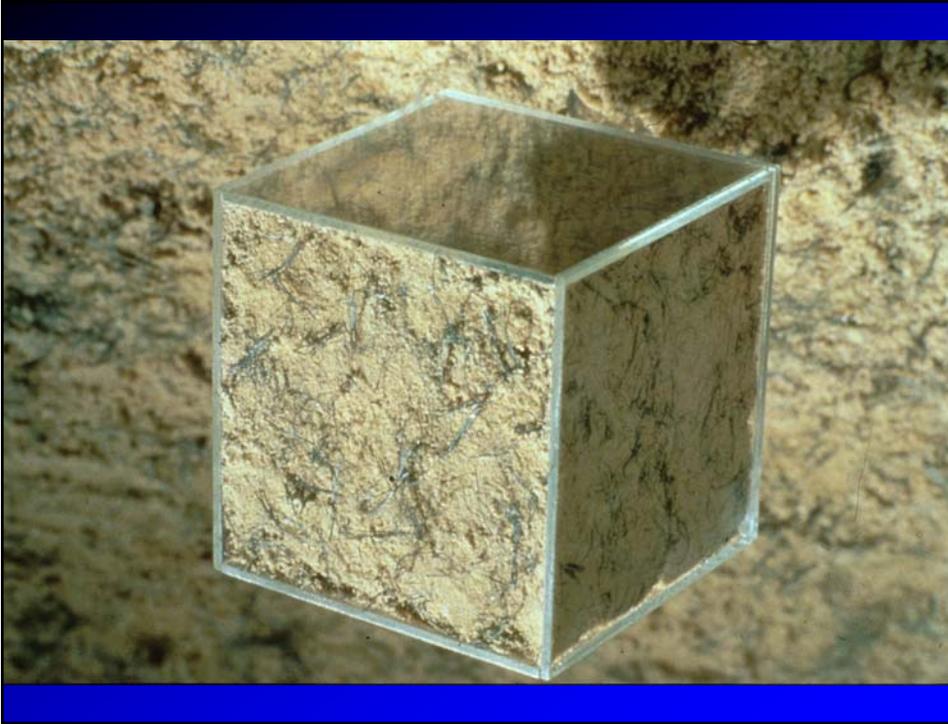
- Horizontal geogrid reinforcements anchored into solid waste
- Evapotranspirative cover system

## *Reinforced Infinite Slope*

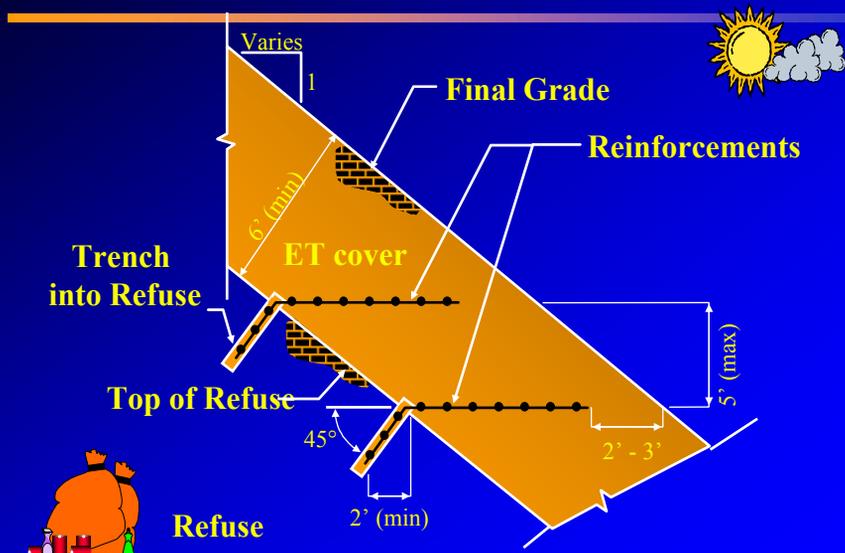
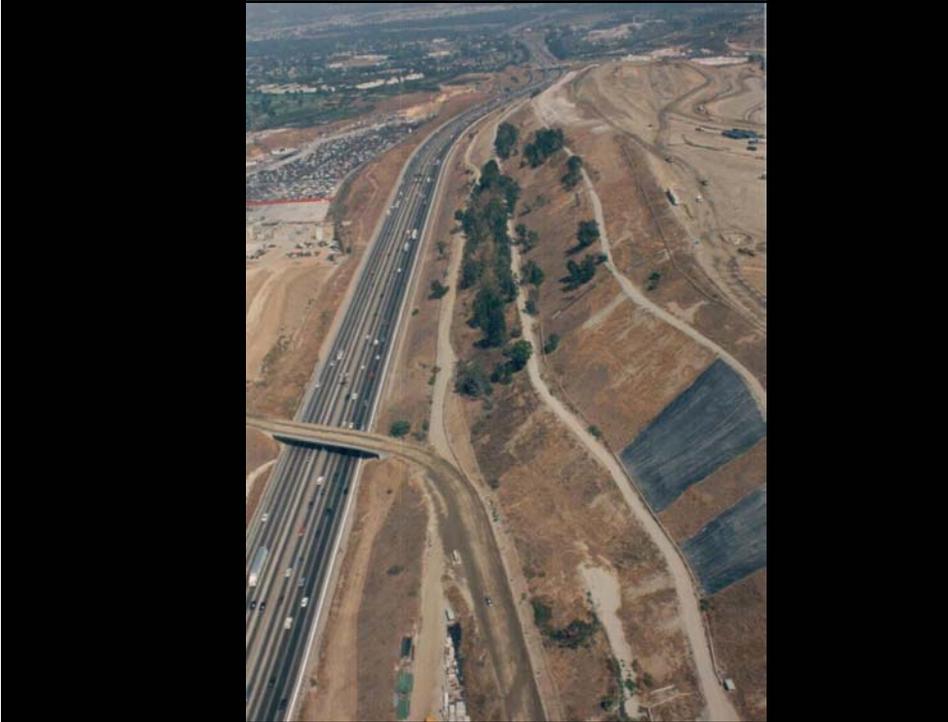
## Reinforced Veneer

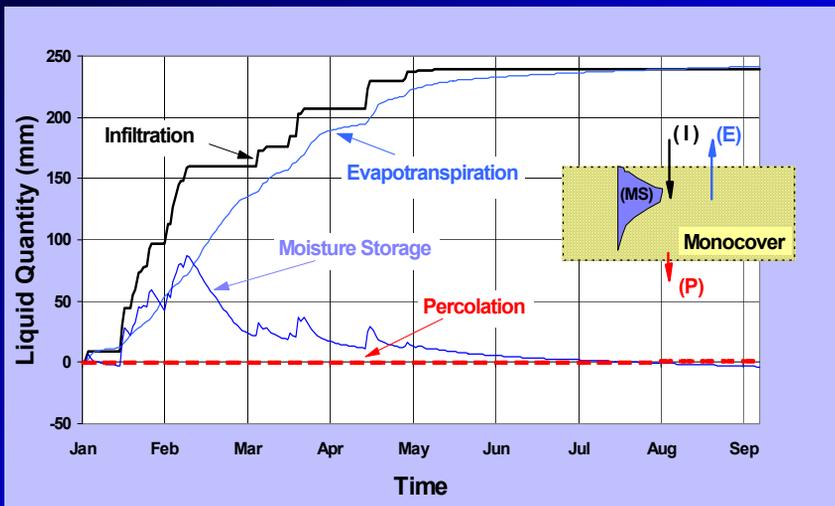
## *How does the ET cover Perform in a Wet Year?*

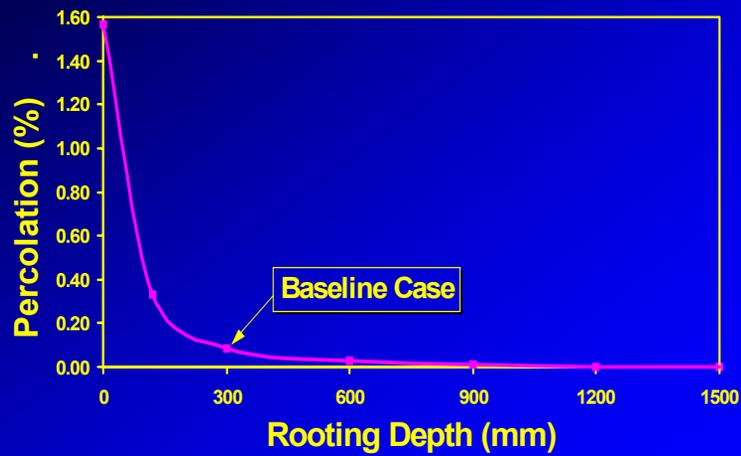
## Parametric Evaluation: Rooting Depth

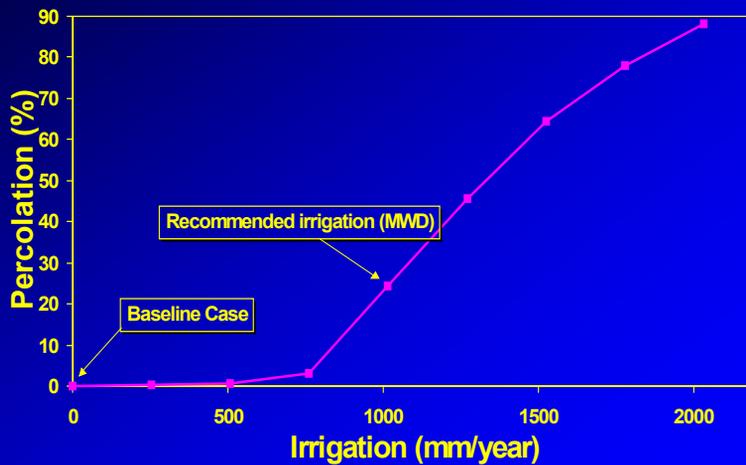
## Parametric Evaluation: Irrigation

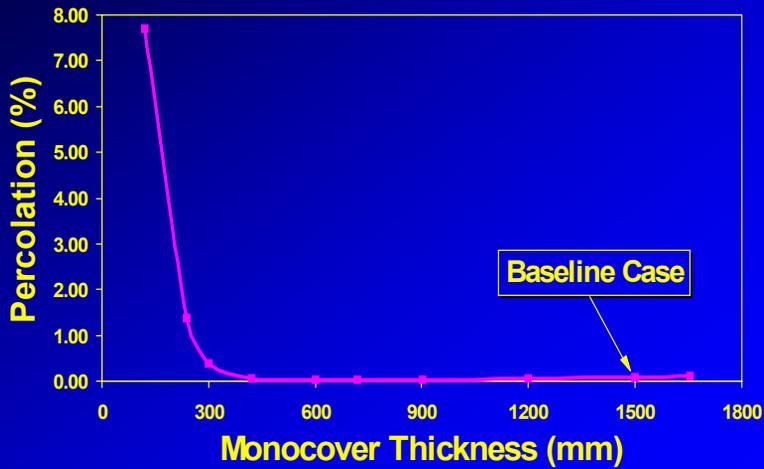
## Parametric Evaluation: Cover Thickness

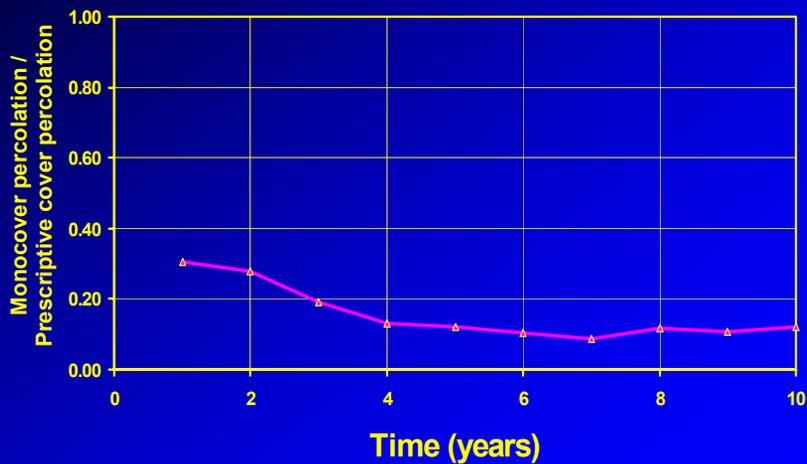
- Design criterion required that the percolation through the proposed ET cover be less than through the prescriptive cover.
- The prescriptive cover was defined by a consent decree as the State of California mandated prescriptive cover.
- The approach for evaluating equivalence was to compare percolation values estimated numerically through both covers when exposed to identical climatic conditions.

## Equivalence Demonstration

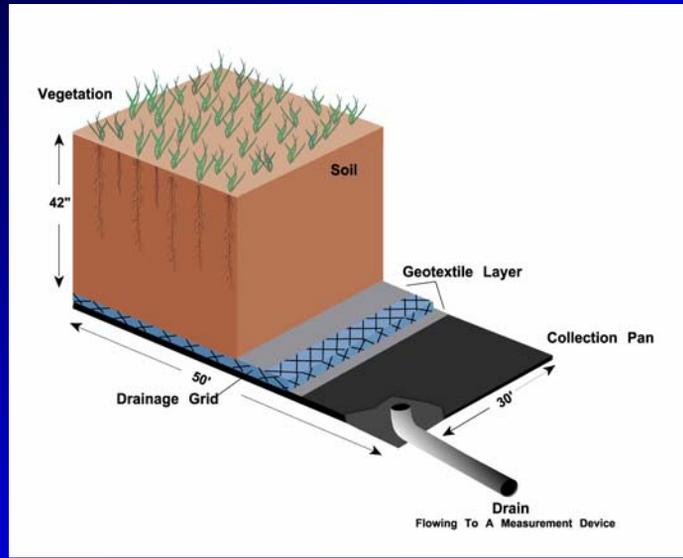
- Design criterion requires that the basal percolation through the proposed ET cover be less than 1.3 mm/year
- Four test covers were constructed using different soil types and cover thickness values ranging from 42 to 60 in.
- Test covers involved lysimeters with sets of TDRs within the test area.

## *Typical Test Cover*

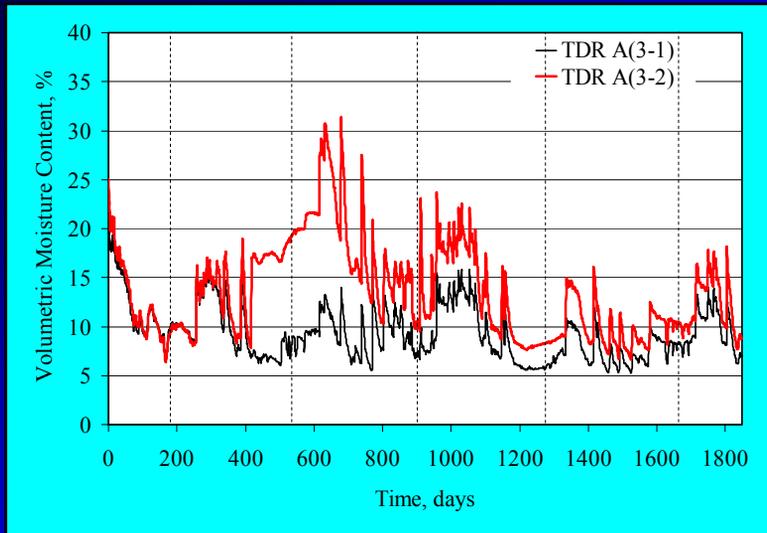
## Problems with Moisture Data

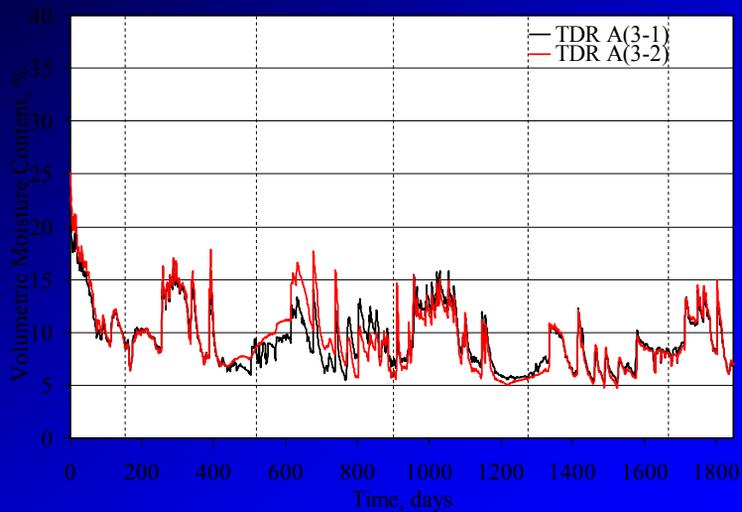
## Problems with Moisture Data: Correction

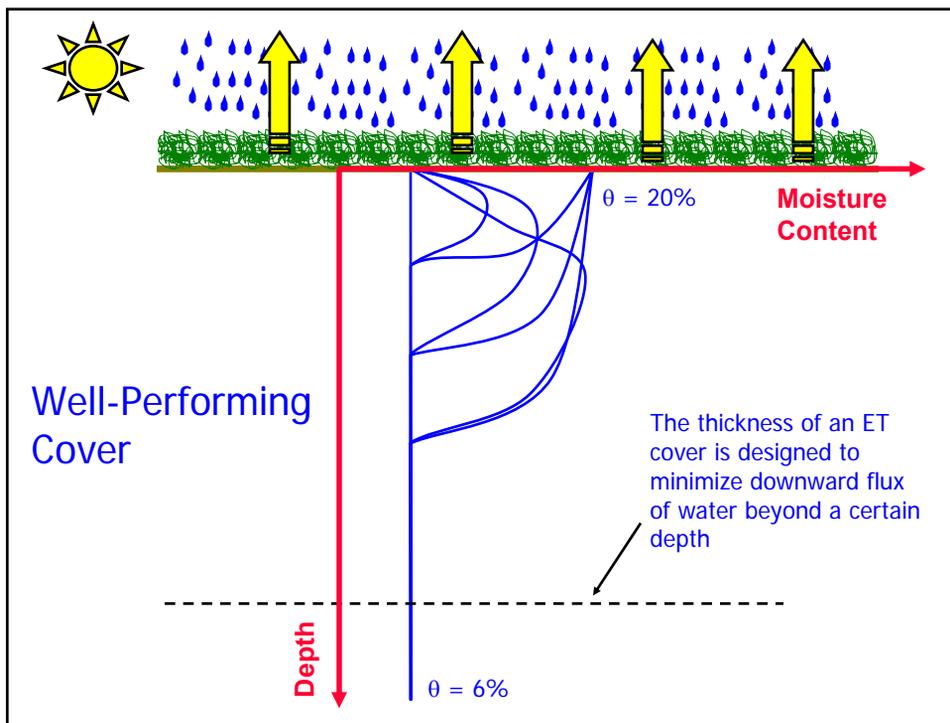
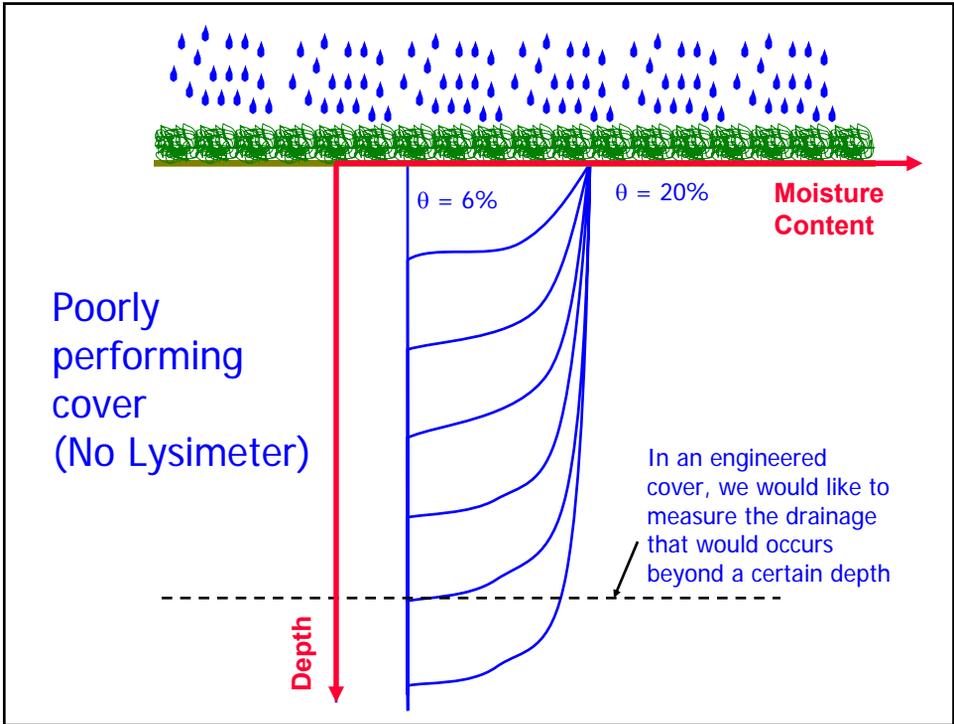
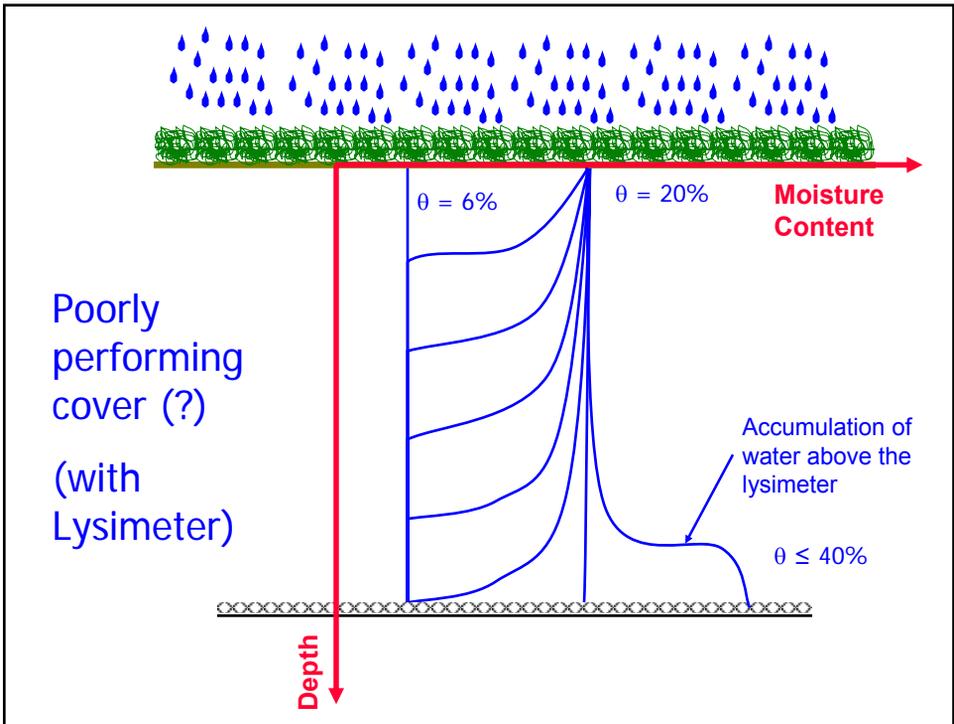
## *Lessons Learned: Capillary Break*

*A capillary break developed at the lysimeter interface in three of the four test plots (1999, 2001, 2003).*

*Development of a capillary break held significant volumes of liquid that would have percolated otherwise.*

- Development of a capillary break prevented downward migration of liquids in excess of the storage capacity of the cover
- While capillary break is beneficial, the cover was not initially designed to account for it
- To achieve equivalence, a similar capillary break should develop in the full-scale cover

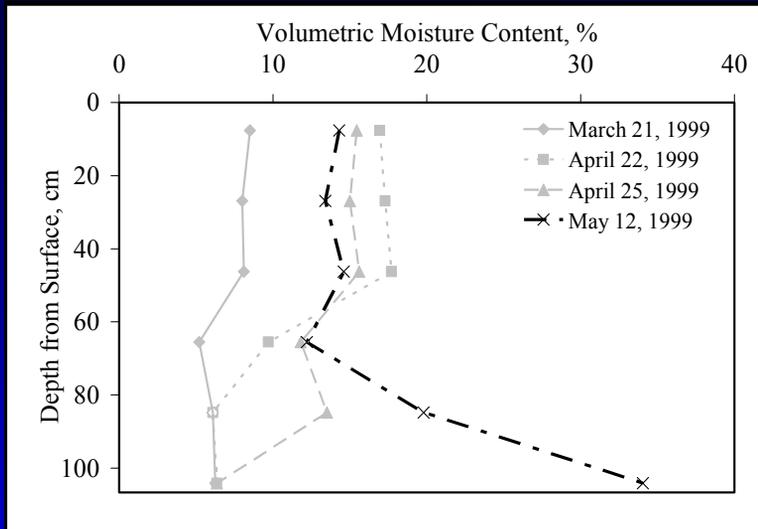
## Advance of Moisture Front in Cover A

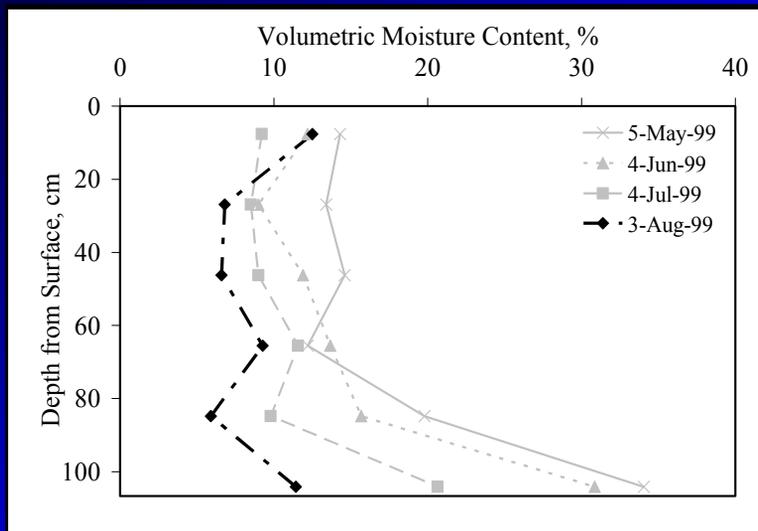
## Retreat of Moisture Front in Cover A

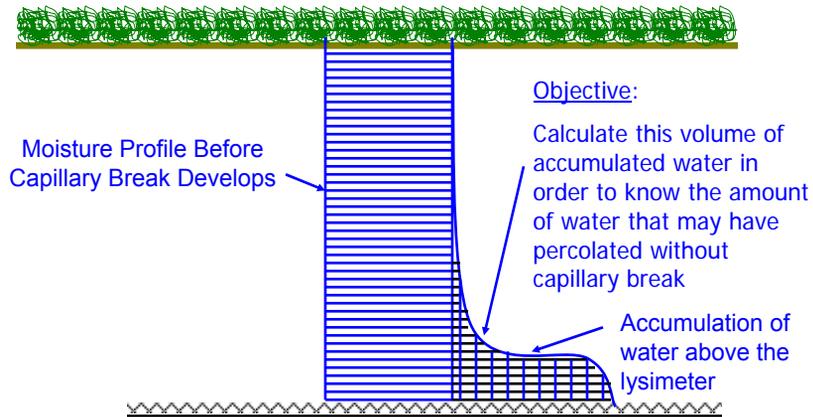
## Quantification of Effect of Capillary Break

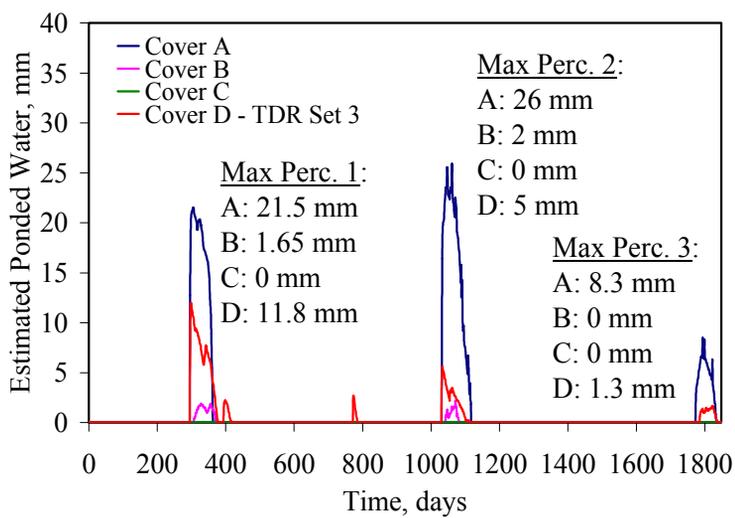
## Estimated Accumulated Water

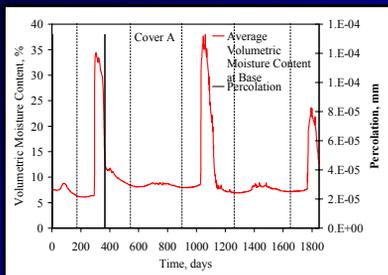
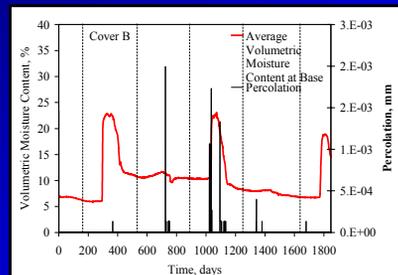
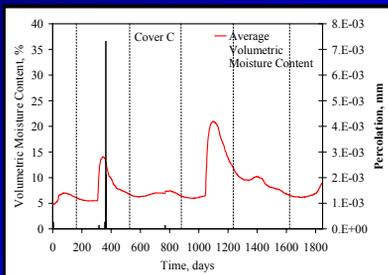
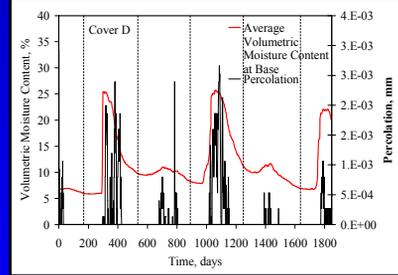
*Due to the capillary break that developed at the interfaces, possibly only preferential flow was collected by the lysimeters*

## Correlation between Moisture at the Base and Percolation

- Available data suggests that test plot lysimeters have collected only preferential flow so far
- Lysimeters have provided little insight into the cover design if uniform flow becomes a relevant mechanism (e.g. if the capillary break does not develop in the final cover)
- Lysimetry and moisture monitoring are complementary and allow evaluation of the different moisture mechanisms

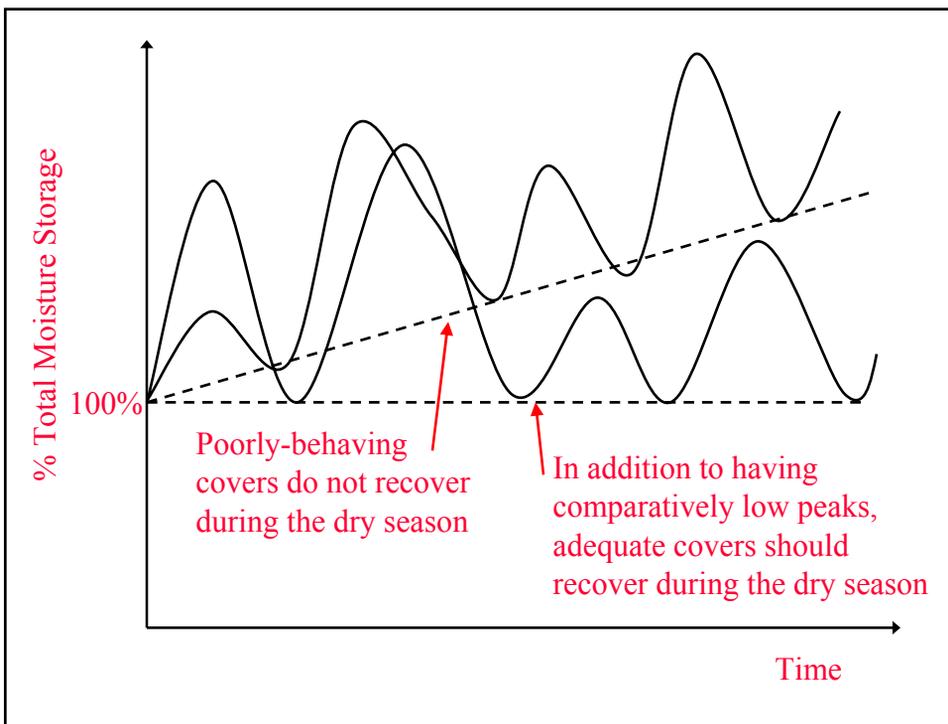
## *Lessons Learned: Long-Term Trends*

*The yearly trends in the test plots indicate that the test plots have recovered their original moisture each year following the dry season.*

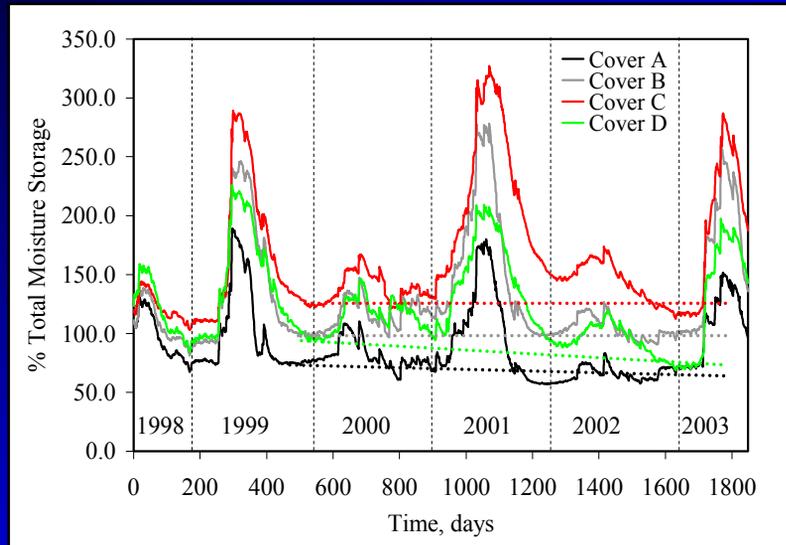
## *Trend in Moisture Storage in the RMA Covers*

- Evaluation of moisture storage allows assessment of the ET cover recovery during the dry season
- The different test plots showed that the covers were able to recover after the wet season
